**DEPARTMENT OF TRANSPORTATION**

Contract #: 04-0120F4Cty: SF/ALA Rte: 80 PM: 13.2/13.9File #: 69.28**WELDING INSPECTION REPORT****Resident Engineer:** Pursell, Gary**Address:** 333 Burma Road**City:** Oakland, CA 94607**Report No:** WIR-003637**Date Inspected:** 10-Aug-2008**Project Name:** SAS Superstructure**OSM Arrival Time:** 630**Prime Contractor:** American Bridge/Fluor Enterprises, a JV**OSM Departure Time:** 1630**Contractor:** Zhenhua Port Machinery Company, Ltd (ZPMC), Changxing Island **Location:** Shanghai, China

**Orthotropic Box Girder (OBG):**

# WELDING INSPECTION REPORT

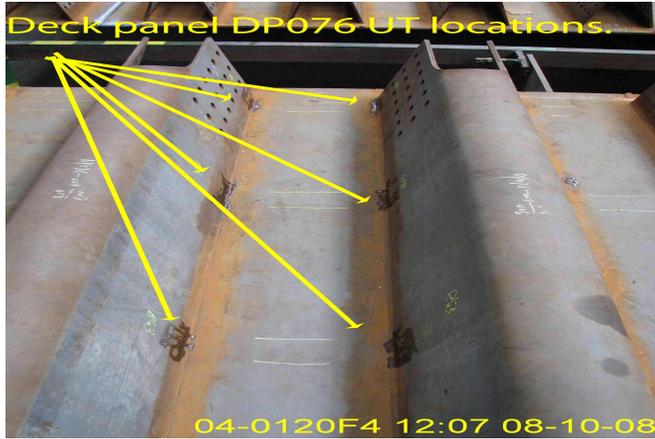
The QA Inspector performed ultrasonic shear wave inspections of the tack weld locations in deck panels DP038-002 weld 6, 7 and 8 as well as DP076-001 weld 1. The purpose of these ultrasonic inspections is to locate potential cracks in the areas where tack welds had been made. The results of these inspections have been recorded and the potential cracked locations will receive a subsequent ultrasonic phased array inspection using the phased array technique. See the photograph below for additional information.
