DEPARTMENT OF TRANSPORTATION

Quality Assurance and Source Inspection

WELDING INSPECTION REPORT

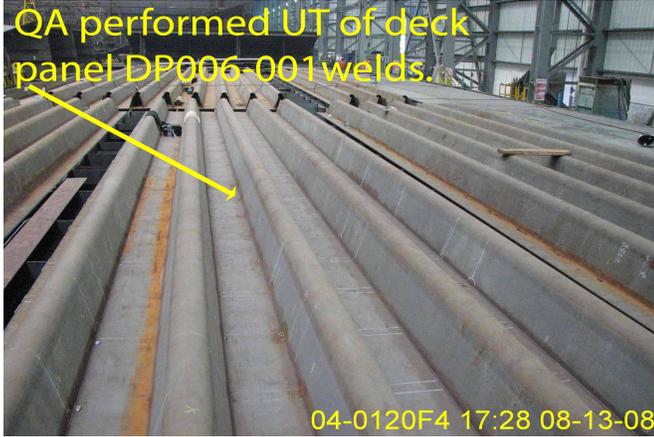
The QA Inspector performed ultrasonic inspection of deck panel closed rib welds in the locations where tack welds had been made. The purpose of these inspections is to detect and document potential cracked tack welds that have subsequently been welded over. Below is a summary of the welds and number of welds that require additional phased array ultrasonic inspections.

Deck panel DP006-001: 8 welds were ultrasonically inspected and 15 relevant indications were identified.

Deck panel DP079-001: 7 welds were ultrasonically inspected and 16 relevant indications were identified.
