Contract #: 04-0120F4Cty: SF/ALA Rte: 80 PM: 13.2/13.9File #: 69.28**WELDING INSPECTION REPORT****Resident Engineer:** Pursell, Gary**Address:** 333 Burma Road**City:** Oakland, CA 94607**Report No:** WIR-003968**Date Inspected:** 26-Aug-2008**Project Name:** SAS Superstructure**OSM Arrival Time:** 700**Prime Contractor:** American Bridge/Fluor Enterprises, a JV**OSM Departure Time:** 1500**Contractor:** Zhenhua Port Machinery Company, Ltd (ZPMC), Changxing Island **Location:** Shanghai, China**CWI Name:** Sun Wei, Chen Chih Chien**CWI Present:** Yes No**Inspected CWI report:** Yes No N/A**Rod Oven in Use:** Yes No N/A**Electrode to specification:** Yes No N/A**Weld Procedures Followed:** Yes No N/A**Qualified Welders:** Yes No N/A**Verified Joint Fit-up:** Yes No N/A**Approved Drawings:** Yes No N/A**Approved WPS:** Yes No N/A**Delayed / Cancelled:** Yes No N/A**Bridge No:** 34-0006**Component:** deck panels, lap plates, bottom & side panels**Summary of Items Observed:****OBG Sub-assembly – Bay 1**

WELDING INSPECTION REPORT

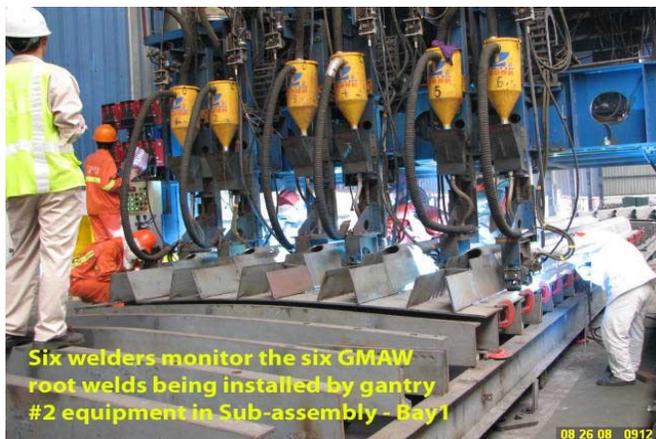
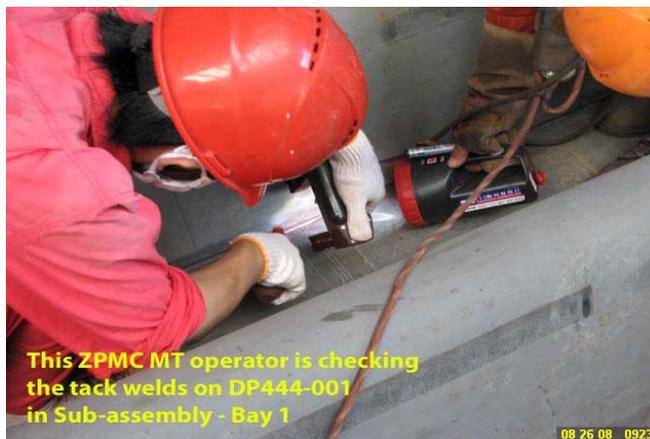
QA Inspector randomly observed approximately 65 ZPMC workers performing the following: FCAW-G of CJP joint at ribs to SP408; fitting and SMAW tacking of ribs to BP35A and grinding of tack welds; approximate 24mm patterned holes being drilled in T-rib ends for BP89; abrasive cleaning in rib welding layout pattern on various side plates. Also present in this bay were ZPMC CWI Chen Chih Chien and ABF QC's Li Jin Bo and Lei Tao. Items observed appeared to comply with project specifications.

ABF QC Lei Tao informed QA Inspector that the FCAW-G weld about to be performed was a CJP weld at the tapered end of the ribs on SP408.
