**DEPARTMENT OF TRANSPORTATION**

Contract #: 04-0120F4Cty: SF/ALA Rte: 80 PM: 13.2/13.9File #: 69.28**WELDING INSPECTION REPORT****Resident Engineer:** Pursell, Gary**Address:** 333 Burma Road**City:** Oakland, CA 94607**Report No:** WIR-003862**Date Inspected:** 10-Sep-2008**Project Name:** SAS Superstructure**OSM Arrival Time:** 1400**Prime Contractor:** American Bridge/Fluor Enterprises, a JV**OSM Departure Time:** 2300**Contractor:** Zhenhua Port Machinery Company, Ltd (ZPMC), Changxing Island **Location:** Shanghai, China**CWI Name:** Chen Chih-Ming**CWI Present:** Yes No**Inspected CWI report:** Yes No N/A**Rod Oven in Use:** Yes No N/A**Electrode to specification:** Yes No N/A**Weld Procedures Followed:** Yes No N/A**Qualified Welders:** Yes No N/A**Verified Joint Fit-up:** Yes No N/A**Approved Drawings:** Yes No N/A**Approved WPS:** Yes No N/A**Delayed / Cancelled:** Yes No N/A**Bridge No:** 34-0006**Component:** OBG side, edge and deck panels**Summary of Items Observed:**

# WELDING INSPECTION REPORT

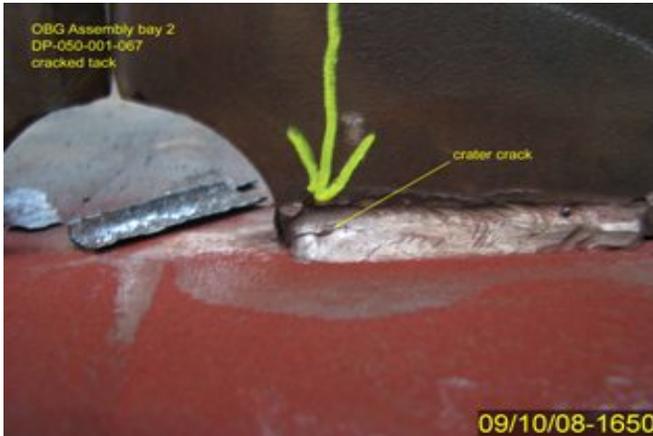
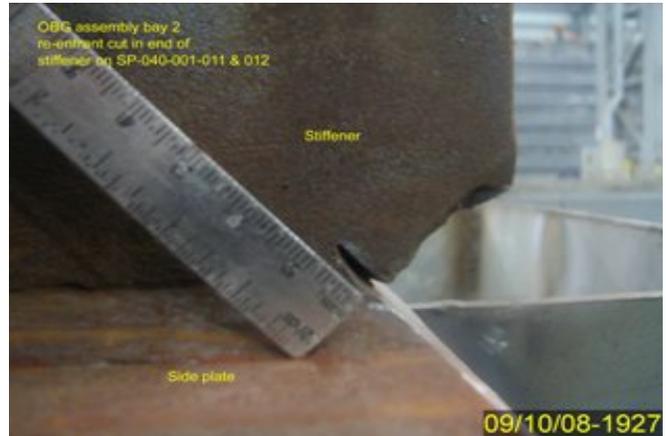
QA was notified by ZPMC QC representative Mr. Testino Wang of 6 cracked tacks on 5 OBG deck panels (DP-049-001-184, DP-051-001-191, DP-050-001-021, DP-050-001-067, DP-074-001-099 and DP-075-001-141). These tacks join the outer diaphragms to the deck plate and u-ribs. ZPMC QC has allowed ZPMC personnel to commence repairing these cracked tacks without an approved repair procedure in the vicinity of the repairs. QC inspector identified as Mr. Geng Wei was unable to produce a procedure upon QA request. As of the end of this shift ZPMC has only removed the cracked tacks by grinding. No further activities concerning repairs of these tacks were observed on this shift. Note: these deck panels are currently in non compliance because ZPMC has commenced fitting and welding the diaphragms after the state issued a letter suspending further fabrication of these deck panels until issues with cracked tacks in the PJP welds joining u-ribs to deck plates have been resolved. ZPMC and ABF have been notified by QA of an impending incident report concerning these issues.

QA observed that ZPMC has cut into the end of 3 stiffeners during the beveling operation on side panel SP-040-01 at the ends of welds 011, 012, 017, 018, 019 and 020. ZPMC CWI identified as Mr. Chen Chih-Ming informed this QA inspector that ZPMC would determine if this was a CWR or not and would submit the proper paper work in order to commence repairing these areas as early as tomorrow (09/11/08).
