Quality Assurance and Source Inspection

Contract #: 04-0120F4Cty: SF/ALA Rte: 80 PM: 13.2/13.9File #: 69.28**WELDING INSPECTION REPORT****Resident Engineer:** Pursell, Gary**Address:** 333 Burma Road**City:** Oakland, CA 94607**Report No:** WIR-004216**Date Inspected:** 23-Sep-2008**Project Name:** SAS Superstructure**OSM Arrival Time:** 700**Prime Contractor:** American Bridge/Fluor Enterprises, a JV**OSM Departure Time:** 1530**Contractor:** Zhenhua Port Machinery Company, Ltd (ZPMC), Changxing Island **Location:** Shanghai, China**CWI Name:** See below**CWI Present:** Yes No**Inspected CWI report:** Yes No N/A**Rod Oven in Use:** Yes No N/A**Electrode to specification:** Yes No N/A**Weld Procedures Followed:** Yes No N/A**Qualified Welders:** Yes No N/A**Verified Joint Fit-up:** Yes No N/A**Approved Drawings:** Yes No N/A**Approved WPS:** Yes No N/A**Delayed / Cancelled:** Yes No N/A**Bridge No:** 34-0006**Component:** Tower & OBG**Summary of Items Observed:**

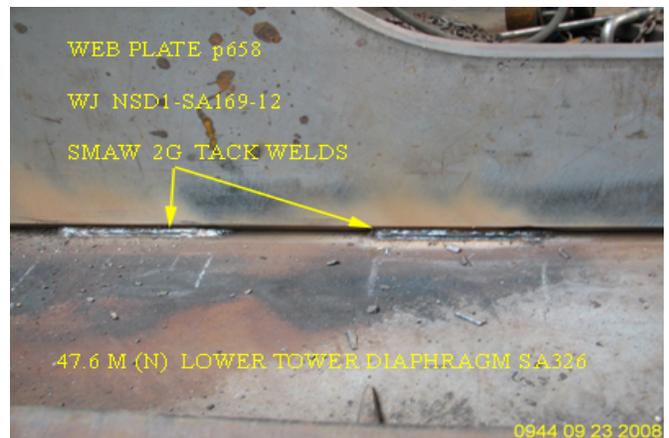
The QA Inspector randomly observed ZPMC welders ID 045133 and 045246, utilizing the SMAW Process in the 2G (Horizontal Groove) Position with ZPMC WPS WPS-3312, to weld the Web Plate p658 to 47.6 M Tower Diaphragm NSD1-SA326 at WJ's NSD1-SA169B/B-11/12. The QA Inspector randomly observed ZPMC QC under the supervision of ZPMC CWI Liu Huajie, monitoring weld parameters. The weld parameters appeared to comply with contract requirements. The attached photograph provides additional detail.
