DEPARTMENT OF TRANSPORTATION

Quality Assurance and Source Inspection

Contract #: 04-0120F4Cty: SF/ALA Rte: 80 PM: 13.2/13.9File #: 69.28**WELDING INSPECTION REPORT****Resident Engineer:** Pursell, Gary**Address:** 333 Burma Road**City:** Oakland, CA 94607**Report No:** WIR-004684**Date Inspected:** 17-Nov-2008**Project Name:** SAS Superstructure**OSM Arrival Time:** 1400**Prime Contractor:** American Bridge/Fluor Enterprises, a JV**OSM Departure Time:** 2300**Contractor:** Zhenhua Port Machinery Company, Ltd (ZPMC), Changxing Island **Location:** Shanghai, China**CWI Name:** Chen Chih-Ming**CWI Present:** Yes No**Inspected CWI report:** Yes No N/A**Rod Oven in Use:** Yes No N/A**Electrode to specification:** Yes No N/A**Weld Procedures Followed:** Yes No N/A**Qualified Welders:** Yes No N/A**Verified Joint Fit-up:** Yes No N/A**Approved Drawings:** Yes No N/A**Approved WPS:** Yes No N/A**Delayed / Cancelled:** Yes No N/A**Bridge No:** 34-0006**Component:** various (see below)**Summary of Items Observed:**

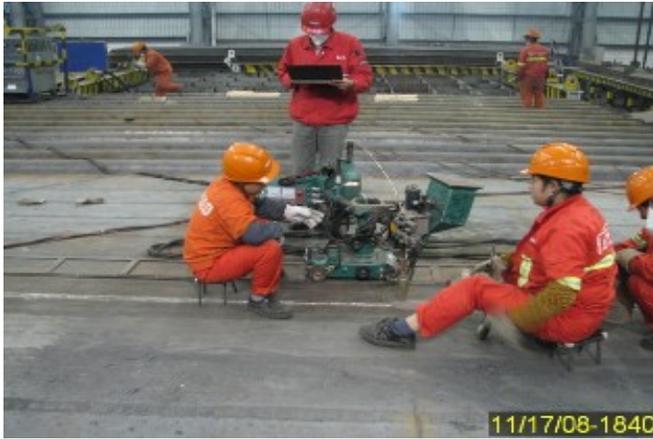
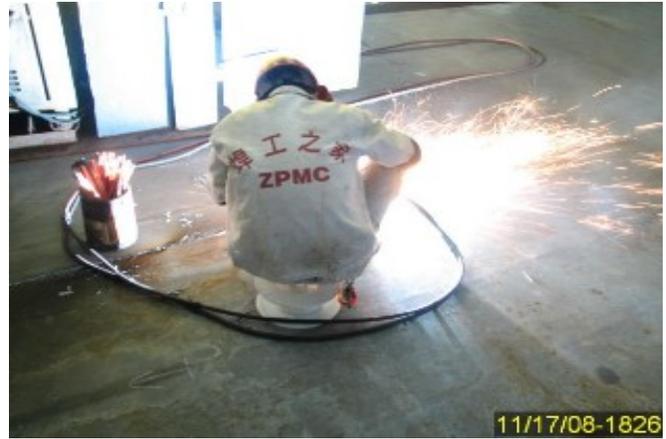
This QA assisted Caltrans QA Mr. Ricardo Mandina perform Gate to Gate (G2G) preliminary Ultrasonic Testing (UT) at tacked areas on u-rib to deck plate PJP welds for the following deck panel:
DP-144-001:

Weld# 1 – 26 tacks UT'ed – 8 indications
Weld# 2 – 26 tacks UT'ed – 5 indications
Weld# 3 – 26 tacks UT'ed – 4 indications
Weld# 4 – 26 tacks UT'ed – 6 indications

The G2G UT on this deck panel is complete. Caltrans QA Mr. Ricardo Mandina recorded the "Y" locations of each indication on the deck panel tack weld assessment sheet and gave the written information to Caltrans QA task leader Mr. Mark Wright to be entered on the Caltrans team China server.
