**DEPARTMENT OF TRANSPORTATION**

Contract #: 04-0120F4Cty: SF/ALA Rte: 80 PM: 13.2/13.9File #: 69.28**WELDING INSPECTION REPORT****Resident Engineer:** Pursell, Gary**Address:** 333 Burma Road**City:** Oakland, CA 94607**Report No:** WIR-004885**Date Inspected:** 04-Dec-2008**Project Name:** SAS Superstructure**OSM Arrival Time:** 630**Prime Contractor:** American Bridge/Fluor Enterprises, a JV**OSM Departure Time:** 1530**Contractor:** Zhenhua Port Machinery Company, Ltd (ZPMC), Changxing Island **Location:** Shanghai, China**CWI Name:** Sun Wei**CWI Present:** Yes No**Inspected CWI report:** Yes No N/A**Rod Oven in Use:** Yes No N/A**Electrode to specification:** Yes No N/A**Weld Procedures Followed:** Yes No N/A**Qualified Welders:** Yes No N/A**Verified Joint Fit-up:** Yes No N/A**Approved Drawings:** Yes No N/A**Approved WPS:** Yes No N/A**Delayed / Cancelled:** Yes No N/A**Bridge No:** 34-0006**Component:** OBG**Summary of Items Observed:**

# WELDING INSPECTION REPORT

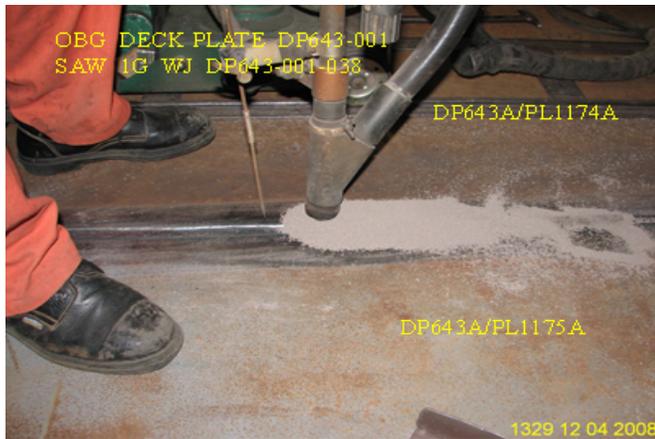
The QA Inspector randomly observed ZPMC welder Wu Zhi Bin ID 049804, utilizing the Submerged Arc Welding (SAW) Process in 1G Position with ZPMC WPS WPS-B-T-2221-B-L2c-S-2, to weld a butt splice Deck

Plate DP643-001 at WJ DP643-001-038 between piece marks DP643A/PL1174A and DP643A/PL1175A. The QA Inspector randomly observed ZPMC QC monitoring weld parameters. Weld parameters appeared to comply with contract requirements. The attached photograph provides additional detail.

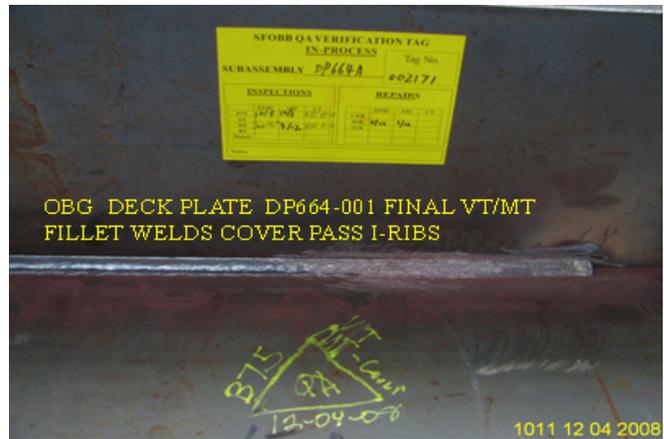
The QA Inspector performed a 100% final Visual Testing (VT) and 10% MT verification on the cover pass of the fillet welds on Deck Plates DP638A Yellow Tag 002170/Green Tag 002189 (DP638-001) Location 7AW WJ's 001 through 006 and Deck Plate DP664A Yellow Tag 002171/Green Tag 002190 (DP664-001) Location 7CE WJ's 001 through 006. There appeared to be no indications and the QA Inspector accepted all the above listed welds. The attached photograph provides additional detail.
