Contract #: 04-0120F4Cty: SF/ALA Rte: 80 PM: 13.2/13.9File #: 69.28**WELDING INSPECTION REPORT****Resident Engineer:** Pursell, Gary**Address:** 333 Burma Road**City:** Oakland, CA 94607**Report No:** WIR-006093**Date Inspected:** 08-Mar-2009**Project Name:** SAS Superstructure**OSM Arrival Time:** 645**Prime Contractor:** American Bridge/Fluor Enterprises, a JV**OSM Departure Time:** 1845**Contractor:** Zhenhua Port Machinery Company, Ltd (ZPMC), Changxing Island **Location:** Shanghai, China**CWI Name:** See Below**CWI Present:** Yes No**Inspected CWI report:** Yes No N/A**Rod Oven in Use:** Yes No N/A**Electrode to specification:** Yes No N/A**Weld Procedures Followed:** Yes No N/A**Qualified Welders:** Yes No N/A**Verified Joint Fit-up:** Yes No N/A**Approved Drawings:** Yes No N/A**Approved WPS:** Yes No N/A**Delayed / Cancelled:** Yes No N/A**Bridge No:** 34-0006**Component:** Tower Fabrication**Summary of Items Observed:**

WELDING INSPECTION REPORT

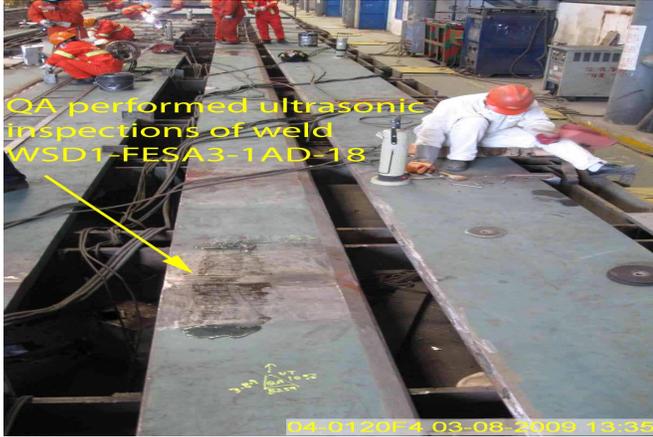
This QA Inspector performed random ultrasonic (UT) inspections of approximately 10 percent length of West Tower Lift 3 Skin plate E stiffener to skin plate welds WSD1-FESA3-1A/D-18. This weld had previously been ultrasonically inspected and accepted by ZPMC inspection personnel. The QA Inspector observed the weld that was ultrasonically inspected by this QA Inspector appear to comply with AWS D1.5 UT requirements. For additional information on this inspection see the TL6027 Ultrasonic Test Report and the photograph below.
