**DEPARTMENT OF TRANSPORTATION**

Contract #: 04-0120F4Cty: SF/ALA Rte: 80 PM: 13.2/13.9File #: 69.28**WELDING INSPECTION REPORT****Resident Engineer:** Pursell, Gary**Address:** 333 Burma Road**City:** Oakland, CA 94607**Report No:** WIR-007327**Date Inspected:** 31-May-2009**Project Name:** SAS Superstructure**OSM Arrival Time:** 700**Prime Contractor:** American Bridge/Fluor Enterprises, a JV**OSM Departure Time:** 1900**Contractor:** Zhenhua Port Machinery Company, Ltd (ZPMC), Changxing Island **Location:** Shanghai, China**CWI Name:** Sun Wei / Sun Bo**CWI Present:** Yes No**Inspected CWI report:** Yes No N/A**Rod Oven in Use:** Yes No N/A**Electrode to specification:** Yes No N/A**Weld Procedures Followed:** Yes No N/A**Qualified Welders:** Yes No N/A**Verified Joint Fit-up:** Yes No N/A**Approved Drawings:** Yes No N/A**Approved WPS:** Yes No N/A**Delayed / Cancelled:** Yes No N/A**Bridge No:** 34-0006**Component:** TOWER**Summary of Items Observed:**

# WELDING INSPECTION REPORT

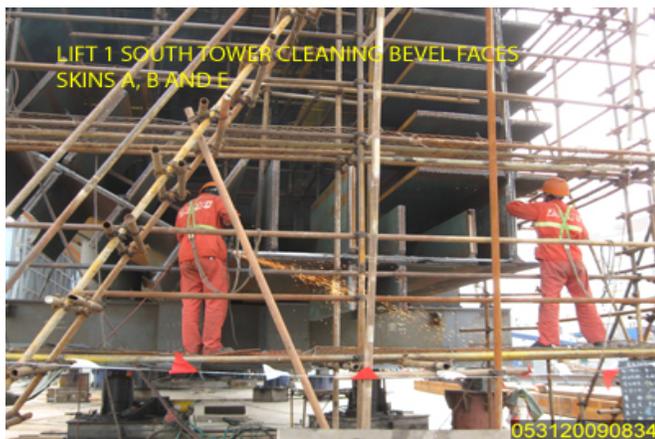
The QA Inspector randomly observed several ZPMC helpers utilizing angle grinders to clean up the bevel faces after torch cutting the bevels on the ends of the longitudinal stiffeners and Skin Plates A through E on Lift 1 South Tower Shaft. The attached photograph provides additional detail.

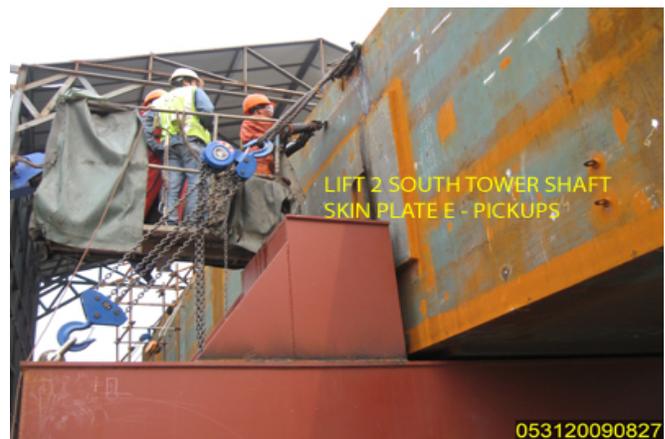
The QA Inspector randomly observed 1 ZPMC helper utilizing an angle grinder to blend pickups on the exterior of Lift 2 South Tower Shaft. The attached photograph provides additional detail.
