**DEPARTMENT OF TRANSPORTATION**

**OBG Trial Assembly Area-**

# WELDING INSPECTION REPORT

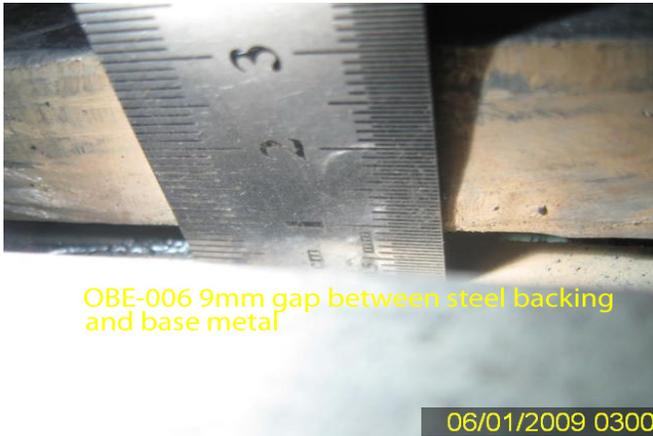
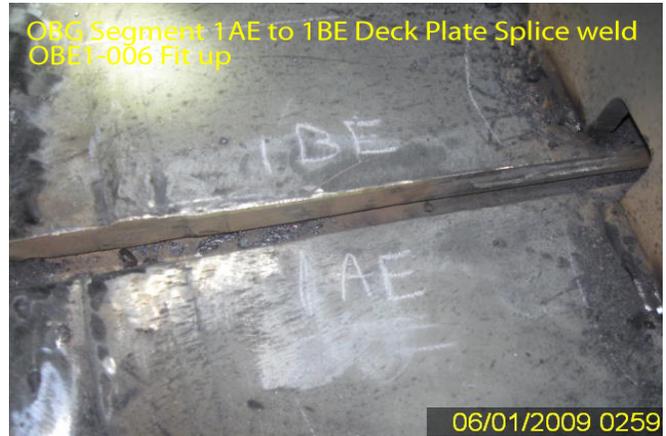
During random visual inspection of OBG segment 1AE to 1BE deck panel Complete Joint Penetration weld OBE1-006 joint fit up, the QA Inspector observed the gap between the bottom of the Deck Plate and steel backing was up to 9 mm for a length of approximately 500 mm. This exceeds the 2mm gap allowed by AWS D1.5 (2002). An Incident report was issued for the noncompliant joint fit up this date. ZPMC QC stated that the backing would be repaired prior to welding. Please see the attached photos below
