**DEPARTMENT OF TRANSPORTATION**

Contract #: 04-0120F4Cty: SF/ALA Rte: 80 PM: 13.2/13.9File #: 69.28**WELDING INSPECTION REPORT****Resident Engineer:** Pursell, Gary**Address:** 333 Burma Road**City:** Oakland, CA 94607**Report No:** WIR-008375**Date Inspected:** 07-Aug-2009**Project Name:** SAS Superstructure**OSM Arrival Time:** 1900**Prime Contractor:** American Bridge/Fluor Enterprises, a JV**OSM Departure Time:** 700**Contractor:** Zhenhua Port Machinery Company, Ltd (ZPMC), Changxing Island **Location:** Shanghai, China**CWI Name:** See Below**CWI Present:** Yes No**Inspected CWI report:** Yes No N/A**Rod Oven in Use:** Yes No N/A**Electrode to specification:** Yes No N/A**Weld Procedures Followed:** Yes No N/A**Qualified Welders:** Yes No N/A**Verified Joint Fit-up:** Yes No N/A**Approved Drawings:** Yes No N/A**Approved WPS:** Yes No N/A**Delayed / Cancelled:** Yes No N/A**Bridge No:** 34-0006**Component:** tower fabrication**Summary of Items Observed:**

## WELDING INSPECTION REPORT

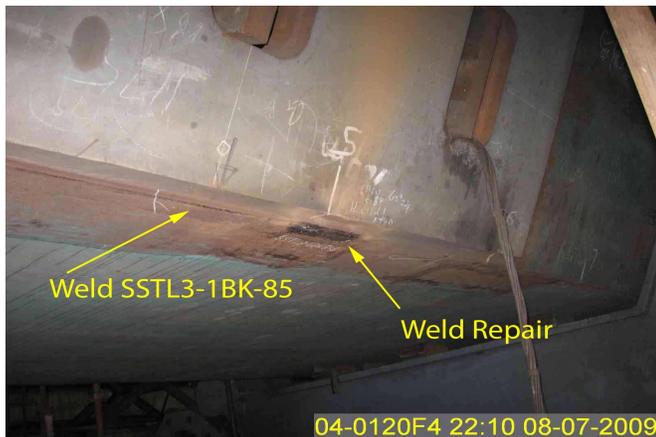
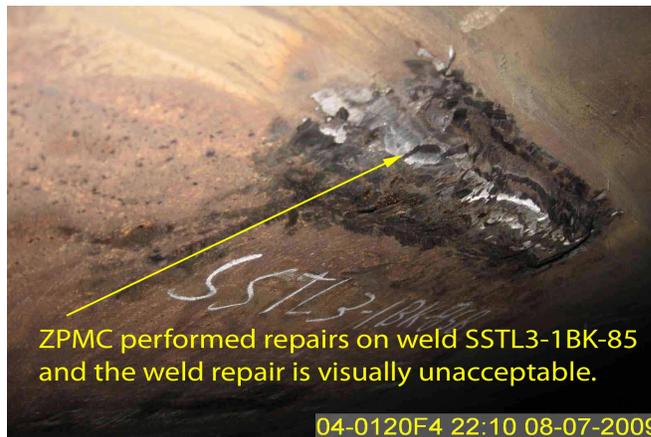
ZPMC issued "Inspection Notification Sheet" number 3887 informing QA that ZPMC has completed ultrasonic inspections of South Tower lift 3 corner weld SSTL3-1BK-85A(B) between skin plate D and skin plate E, and this inspection is limited to the three locations for a distance of 1200 mm each where this weld is located between the double diaphragms. This QA Inspector performed a random visual inspection of the exterior surface of weld SSTL3-1BK-85B in the locations that are referenced above and observed ZPMC appears to have performed a weld repair of this weld where the upper double diaphragm is located. This QA Inspector observed the weld repair is visually rejectable due to having excessive reinforcement, weld spatter and improper transition with the base material. This QA Inspector informed ZPMC CWI Mr. Wang Chuan Qing that ZPMC appears to have performed a weld repair in one of the areas that are referenced on the "Inspection Notification Sheet" and that the weld appears to be visually rejected. AWS D1.5 Welding Code requires all welds to be visually accepted prior to performing any non destructive testing and ZPMC should not perform ultrasonic inspections since this weld is

visually rejectable. Mr. Wang Chuan Qing informed this QA Inspector that he agrees the weld is visually rejectable and that ZPMC will need to grind the weld surface prior to Mr. Xu Li Fuli is qualified to make this weld performing nondestructive inspections. See the photographs below for additional information. Items observed by this QA Inspector do not appear to be progressing in compliance with project specifications and this QA Inspector issued a TL-015 Incident Report to document this visual rejection.
