DEPARTMENT OF TRANSPORTATION

Quality Assurance and Source Inspection

Contract #: 04-0120F4Cty: SF/ALA Rte: 80 PM: 13.2/13.9File #: 69.28**WELDING INSPECTION REPORT****Resident Engineer:** Pursell, Gary**Address:** 333 Burma Road**City:** Oakland, CA 94607**Report No:** WIR-008415**Date Inspected:** 09-Aug-2009**Project Name:** SAS Superstructure**OSM Arrival Time:** 645**Prime Contractor:** American Bridge/Fluor Enterprises, a JV**OSM Departure Time:** 1845**Contractor:** Zhenhua Port Machinery Company, Ltd (ZPMC), Changxing Island **Location:** Shanghai, China**CWI Name:** CX2228.**CWI Present:** Yes No**Inspected CWI report:** Yes No N/A**Rod Oven in Use:** Yes No N/A**Electrode to specification:** Yes No N/A**Weld Procedures Followed:** Yes No N/A**Qualified Welders:** Yes No N/A**Verified Joint Fit-up:** Yes No N/A**Approved Drawings:** Yes No N/A**Approved WPS:** Yes No N/A**Delayed / Cancelled:** Yes No N/A**Bridge No:** 34-0006**Component:** Tower Components**Summary of Items Observed:**

WELDING INSPECTION REPORT

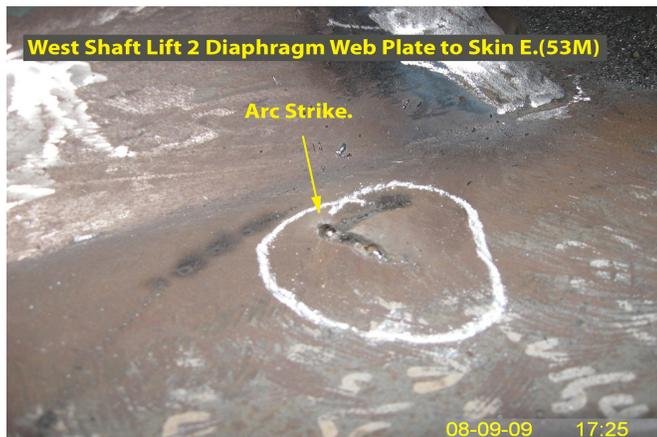
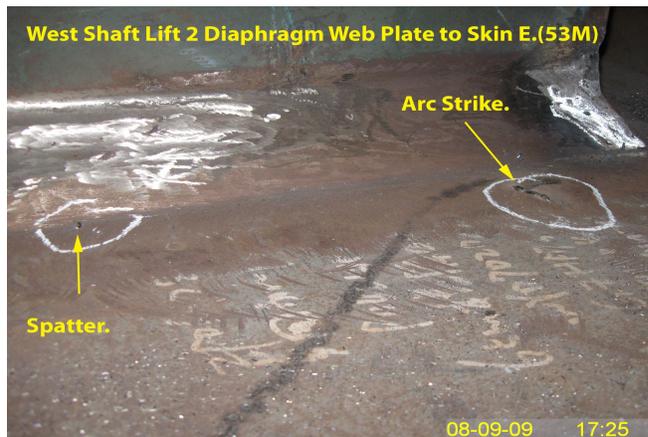
Notification # 003900. West shaft , Lift 2, 53M. (Diaphragm Web Plate to Skin E). Arc Strike Found near Inspection Area. ZPMC Q.C. will remove Arc strike & carry out M.T. on the same area. ZPMC will call C.T. Q.A. for Inspection. Weld joint number not provided so, No Document has been signed for the Inspection. The attached photographs provide additional detail.
