DEPARTMENT OF TRANSPORTATION

Contract #: 04-0120F4Cty: SF/ALA Rte: 80 PM: 13.2/13.9File #: 69.28**WELDING INSPECTION REPORT****Resident Engineer:** Pursell, Gary**Address:** 333 Burma Road**City:** Oakland, CA 94607**Report No:** WIR-008466**Date Inspected:** 15-Aug-2009**Project Name:** SAS Superstructure**OSM Arrival Time:** 1900**Prime Contractor:** American Bridge/Fluor Enterprises, a JV**OSM Departure Time:** 700**Contractor:** Zhenhua Port Machinery Company, Ltd (ZPMC), Changxing Island **Location:** Shanghai, China**CWI Name:** Li Yan Hua**CWI Present:** Yes No**Inspected CWI report:** Yes No N/A**Rod Oven in Use:** Yes No N/A**Electrode to specification:** Yes No N/A**Weld Procedures Followed:** Yes No N/A**Qualified Welders:** Yes No N/A**Verified Joint Fit-up:** Yes No N/A**Approved Drawings:** Yes No N/A**Approved WPS:** Yes No N/A**Delayed / Cancelled:** Yes No N/A**Bridge No:** 34-0006**Component:** OBG segments**Summary of Items Observed:**

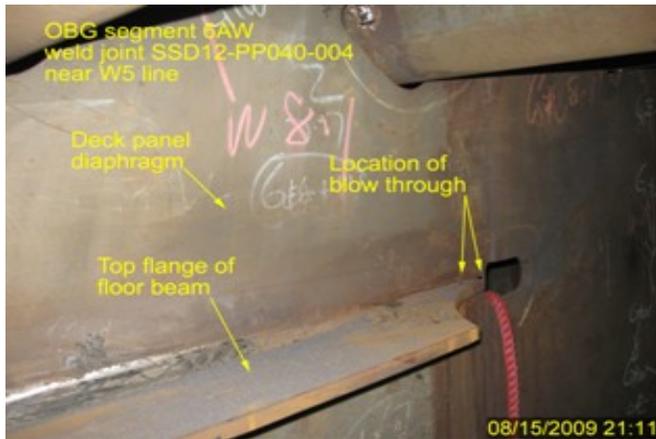
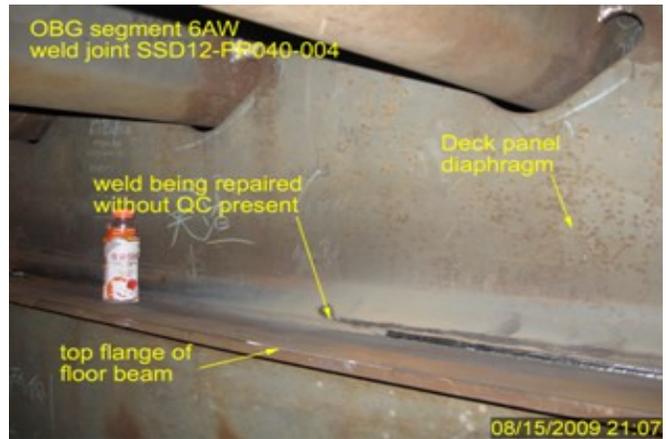
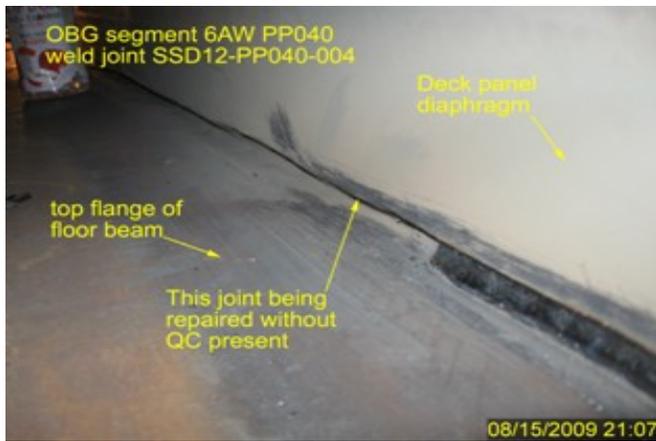
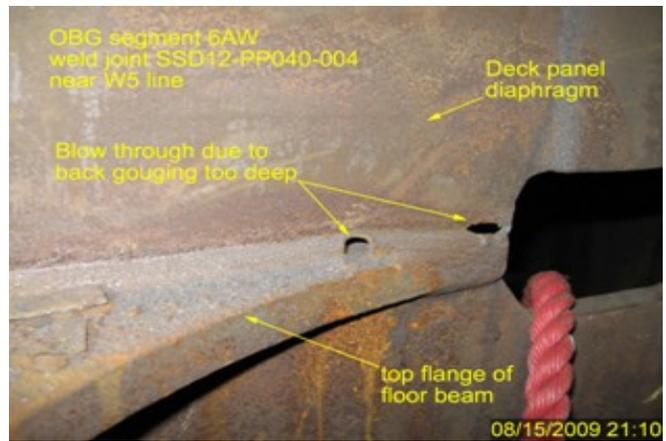
Between the times of 20:45 and 21:25 this QA observed ZPMC qualified welding personnel identified as 201583 and 045240 perform weld repairs on OBG segment identified as 6AW weld joint identified as SSD12-PP040-004. The contractor's Quality Control inspector (QC) was not present to monitor the repairs. The project's contract special provisions section 8-3.01 states "QC inspections shall be provided to ensure continuous inspection when any welding is being performed. Continuous inspection, as a minimum, shall include (1) having QC Inspectors continually present on the shop floor or project site when any welding operation is being performed, and (2) having a QC Inspector within such close proximity of all welders or operators so that inspections by the QC Inspector of each operation, at each welding location, shall not lapse for a period exceeding 30 minutes". ZPMC QC CWI identified as Mr. Li Yan Hua arrived in the vicinity of this segment at approximately 21:25 hrs. This QA asked Mr. Li if he could show QA the weld monitoring report for this weld and welders. Mr. Li informed this QA that although he is in charge of this OBG segment he was not personally responsible for checking and recording the welding parameters for this weld and welders. Mr. Li then informed this QA that the QC inspector that was responsible had left the area prematurely. Mr. Li was unable to produce any information regarding compliance to an applicable WPS. This QA informed Mr. Li that an incident report would be generated for this issue.

This QA also observed two holes measuring approximately 6 to 7mm that have been blown all the way through the same weld mentioned above (SSD12-PP040-004). The holes were created when welders back gouged the weld too deep and inadvertently blew through the weld and base metal. Due to the unavailability of QC in this segment, this QA was unable to inform QC of this discrepancy. See attached pictures. This QA also observed two holes measuring approximately 6 to 7mm that have been blown all the way through the same weld mentioned above (SSD12-PP040-004). The holes were created when welders back gouged the weld too deep and inadvertently blew through the weld and base metal. Due to the unavailability of QC in this segment, this QA was unable to inform QC of this discrepancy. See attached pictures.
