**DEPARTMENT OF TRANSPORTATION**

Contract #: 04-0120F4Cty: SF/ALA Rte: 80 PM: 13.2/13.9File #: 69.28**WELDING INSPECTION REPORT****Resident Engineer:** Pursell, Gary**Address:** 333 Burma Road**City:** Oakland, CA 94607**Report No:** WIR-008837**Date Inspected:** 28-Aug-2009**Project Name:** SAS Superstructure**OSM Arrival Time:** 1900**Prime Contractor:** American Bridge/Fluor Enterprises, a JV**OSM Departure Time:** 700**Contractor:** Zhenhua Port Machinery Company, Ltd (ZPMC), Changxing Island **Location:** Shanghai, China**CWI Name:** CWI: Liu Yang**CWI Present:** Yes No**Inspected CWI report:** Yes No N/A**Rod Oven in Use:** Yes No N/A**Electrode to specification:** Yes No N/A**Weld Procedures Followed:** Yes No N/A**Qualified Welders:** Yes No N/A**Verified Joint Fit-up:** Yes No N/A**Approved Drawings:** Yes No N/A**Approved WPS:** Yes No N/A**Delayed / Cancelled:** Yes No N/A**Bridge No:** 34-0006**Component:** Tower components**Summary of Items Observed:**

## WELDING INSPECTION REPORT

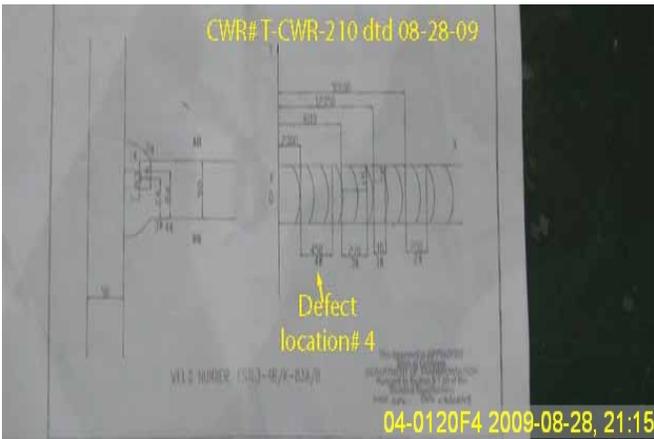
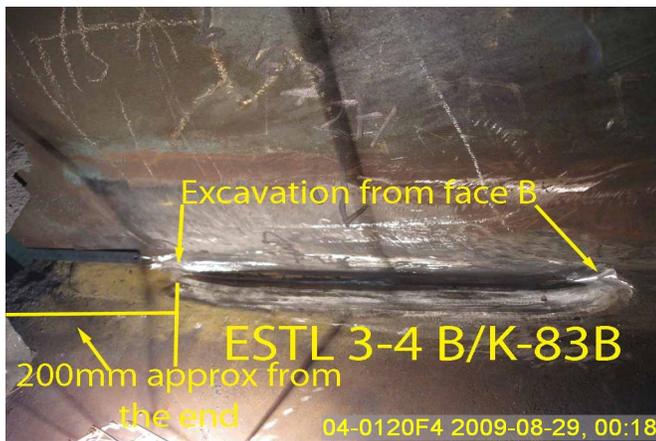
During random Inspection in Bay# 11 this QA Inspector observed that the repair for weld joint# ESTL3-4 B/K-83A/B was being prepared in the presence of ZPMC QC Zhang Bo. After this QA Inspector verified the Critical Welding Report (CWR)# T-CWR-210 and the weld map, it appeared that defect location# 4, as confirmed by the ZPMC QC and the location of the excavation did not match as detailed in the CWR and attached UT report.

This QA Inspector asked ZPMC QC representative Shen Xue Jun why the location of the where the critical weld repair location does not match the location indicated on the ultrasonic inspection report. Shen Xue Jun informed this QA Inspector that he does not know why the locations do not match and that ZPMC will not perform any welding repairs at this location until ZPMC revises the critical weld repair document.

Defect#4 starts @ 2300mm from Y ref and length 450mm
