**DEPARTMENT OF TRANSPORTATION**

Contract #: 04-0120F4Cty: SF/ALA Rte: 80 PM: 13.2/13.9File #: 69.28**WELDING INSPECTION REPORT****Resident Engineer:** Pursell, Gary**Address:** 333 Burma Road**City:** Oakland, CA 94607**Report No:** WIR-008897**Date Inspected:** 04-Sep-2009**Project Name:** SAS Superstructure**OSM Arrival Time:** 700**Prime Contractor:** American Bridge/Fluor Enterprises, a JV**OSM Departure Time:** 1900**Contractor:** Zhenhua Port Machinery Company, Ltd (ZPMC), Changxing Island **Location:** Shanghai, China**CWI Name:** Zhu Tian Shu**CWI Present:** Yes No**Inspected CWI report:** Yes No N/A**Rod Oven in Use:** Yes No N/A**Electrode to specification:** Yes No N/A**Weld Procedures Followed:** Yes No N/A**Qualified Welders:** Yes No N/A**Verified Joint Fit-up:** Yes No N/A**Approved Drawings:** Yes No N/A**Approved WPS:** Yes No N/A**Delayed / Cancelled:** Yes No N/A**Bridge No:** 34-0006**Component:** Crossbeams**Summary of Items Observed:**

**OBG CROSS BEAM CB1**

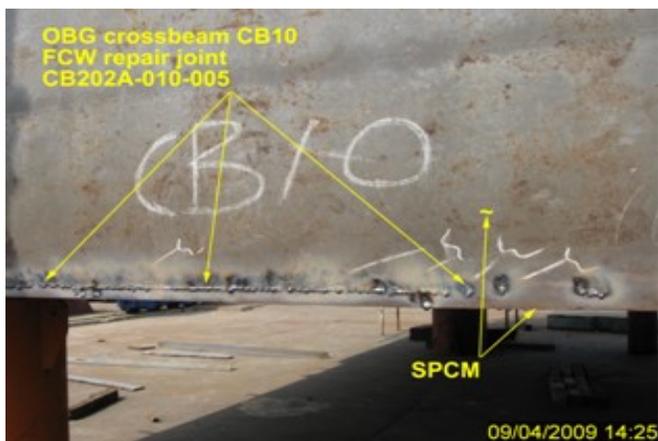
During random in process Visual Testing (VT) this QA observed excessive grinding at the toe of floor beam corner section weld identified as FB205-041-022. ZPMC had previously performed a weld repair in this area and re-inspected the weld using Ultrasonic Testing (UT) and Magnetic particle Testing (MT). This QA measured the depth at 1.5mm. ABF inspector identified as Mr. Wang Wen Bin concurred with QA and instructed ZPMC QC to

repair and re-inspect using MT and UT methods as required by the contract documents.
