Contract #: 04-0120F4Cty: SF/ALA Rte: 80 PM: 13.2/13.9File #: 69.28**WELDING INSPECTION REPORT****Resident Engineer:** Pursell, Gary**Address:** 333 Burma Road**City:** Oakland, CA 94607**Report No:** WIR-008901**Date Inspected:** 11-Sep-2009**Project Name:** SAS Superstructure**OSM Arrival Time:** 700**Prime Contractor:** American Bridge/Fluor Enterprises, a JV**OSM Departure Time:** 1900**Contractor:** Zhenhua Port Machinery Company, Ltd (ZPMC), Changxing Island **Location:** Shanghai, China

Bridge No: 34-0006**Component:** Crossbeams and cantilever brackets**Summary of Items Observed:**

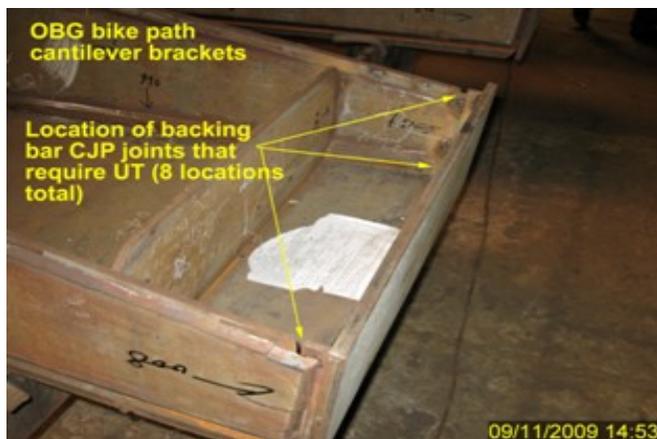
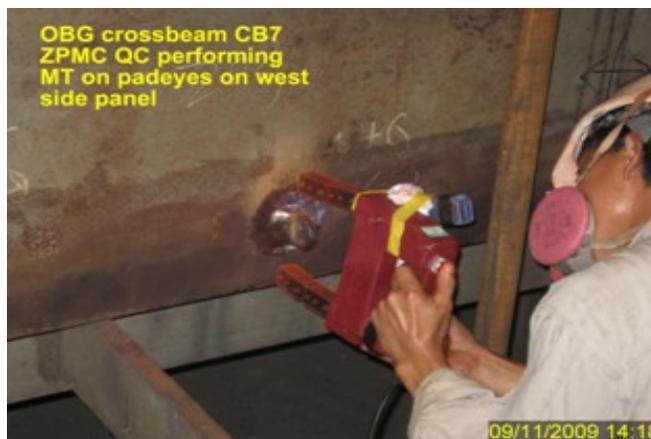
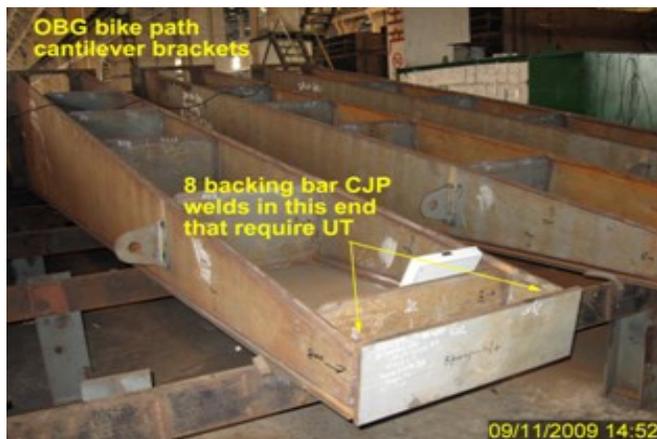
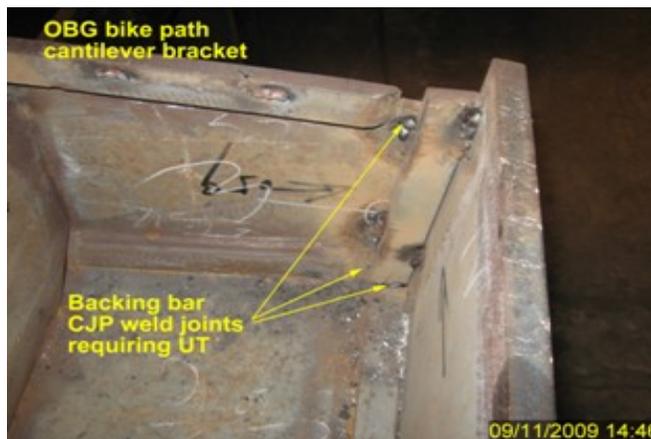
This QA observed that the contractor did not notify Caltrans QA to perform verification Ultrasonic Testing (UT) of the backing bar splice joints prior to fitting and welding the final plate making these welds inaccessible for UT. This condition exists on the following bike path cantilever brackets: BK001-019, 020, 021, 022, 023, 024, 025, 026, 027, 028, 029 and 030. AWS D1.5 2002 section 6.6.6 states "The Contractor shall schedule NDT to facilitate

attendance by the QA Inspector. The QA Inspector shall be advised by the Contractor of operational and NDT schedules and scheduled changes". This QA informed ZPMC QC inspector identified as Mr. Xu Hong Min and ABF inspector identified as Mr. Yu Kun Ming of the above mentioned issue and that an incident report will be generated for this issue. The attached photos are for reference only and are not the actual cantilever brackets affected by the above mentioned incident.
