Contract #: 04-0120F4Cty: SF/ALA Rte: 80 PM: 13.2/13.9File #: 69.28**WELDING INSPECTION REPORT****Resident Engineer:** Pursell, Gary**Address:** 333 Burma Road**City:** Oakland, CA 94607**Report No:** WIR-008997**Date Inspected:** 10-Sep-2009**Project Name:** SAS Superstructure**OSM Arrival Time:** 700**Prime Contractor:** American Bridge/Fluor Enterprises, a JV**OSM Departure Time:** 1900**Contractor:** Zhenhua Port Machinery Company, Ltd (ZPMC), Changxing Island **Location:** Shanghai, China

Bridge No: 34-0006**Component:** OBG Segments**Summary of Items Observed:**

WELDING INSPECTION REPORT

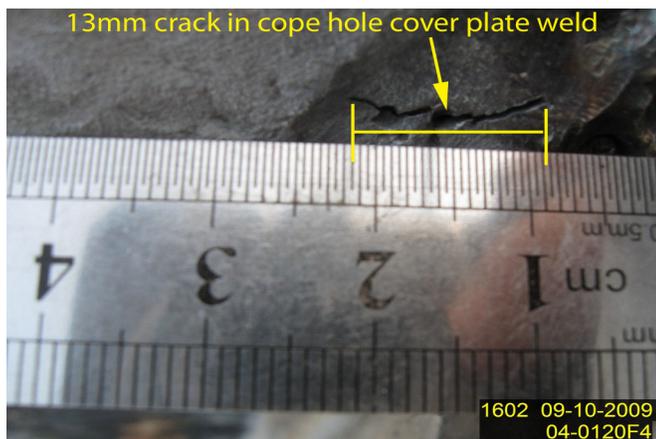
During random visual inspection the Caltrans QA Inspector discovered a visual crack approximately 13mm in length on a fillet weld located at the cover plate for the cope hole of plate Bkx4B. An Incident Report was generated for this item.

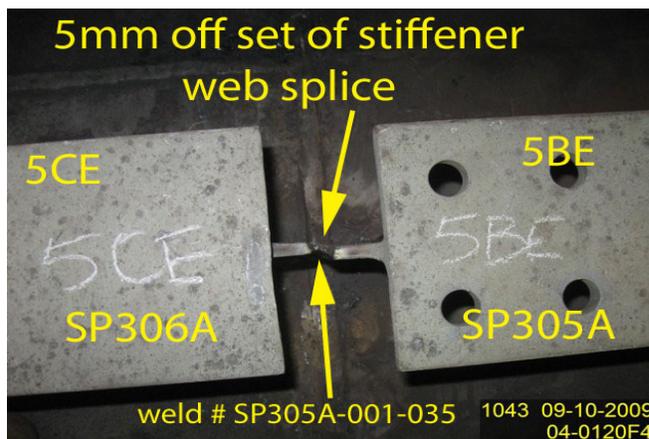
During random visual inspection the Caltrans QA Inspector discovered that the Side Plate T-Stiffener web splice fit up had a 5mm off set. At the time of QA inspection the welding had already been performed and the root pass had been back gouged. The web splice is at the 5BE/5CE segment splice on Side Plates SP306A (5CE) and SP305A (5BE) weld # SP305A-001-035. An Incident Report was generated for this item.
