**DEPARTMENT OF TRANSPORTATION**

Contract #: 04-0120F4Cty: SF/ALA Rte: 80 PM: 13.2/13.9File #: 69.28**WELDING INSPECTION REPORT****Resident Engineer:** Pursell, Gary**Address:** 333 Burma Road**City:** Oakland, CA 94607**Report No:** WIR-009145**Date Inspected:** 18-Sep-2009**Project Name:** SAS Superstructure**OSM Arrival Time:** 700**Prime Contractor:** American Bridge/Fluor Enterprises, a JV**OSM Departure Time:** 1900**Contractor:** Zhenhua Port Machinery Company, Ltd (ZPMC), Changxing Island **Location:** Shanghai, China**CWI Name:** Chen Xi**CWI Present:** Yes No**Inspected CWI report:** Yes No N/A**Rod Oven in Use:** Yes No N/A**Electrode to specification:** Yes No N/A**Weld Procedures Followed:** Yes No N/A**Qualified Welders:** Yes No N/A**Verified Joint Fit-up:** Yes No N/A**Approved Drawings:** Yes No N/A**Approved WPS:** Yes No N/A**Delayed / Cancelled:** Yes No N/A**Bridge No:** 34-0006**Component:** OBG Crossbeams**Summary of Items Observed:**

**OBG CROSS BEAM CB1**

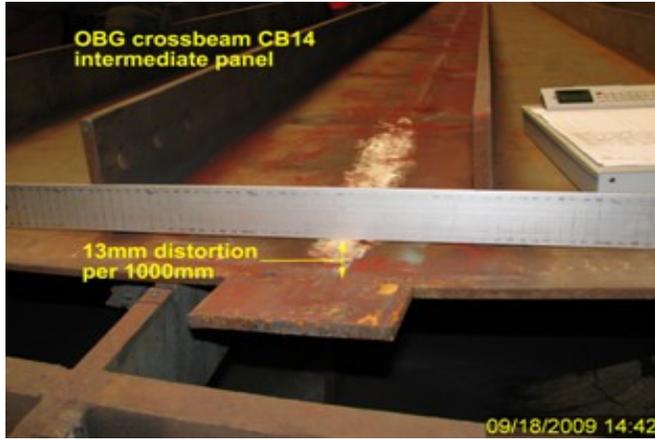
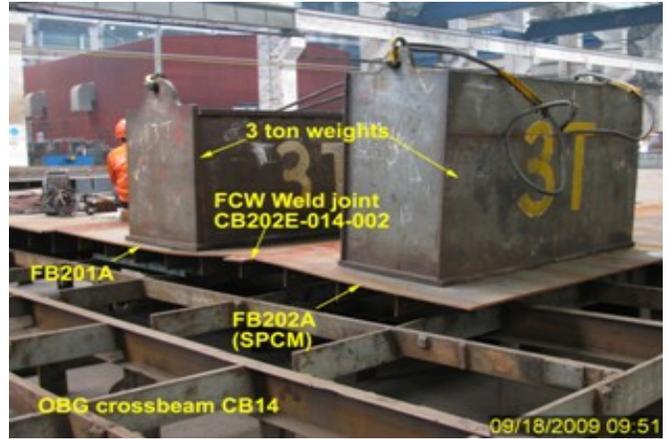
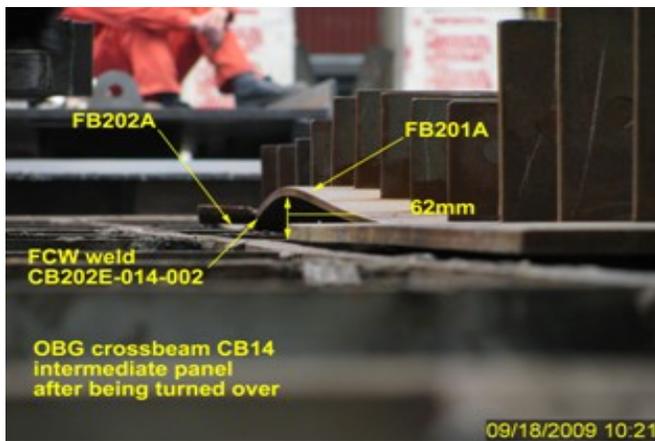
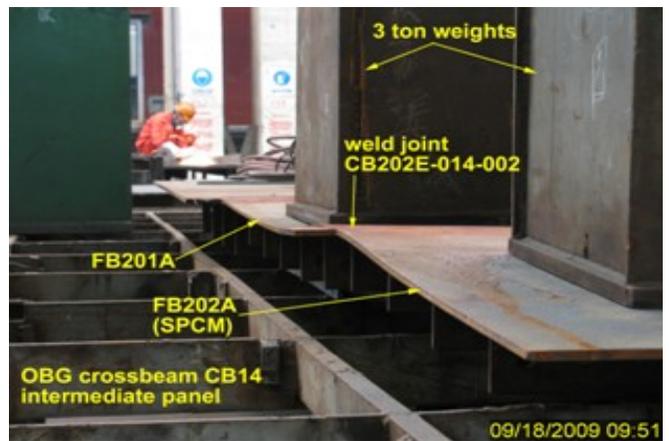
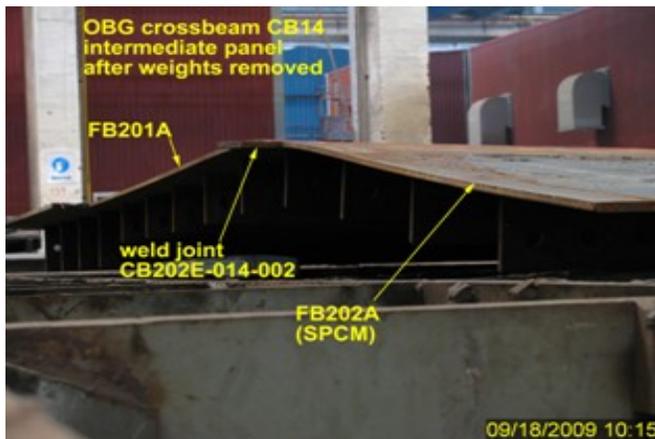
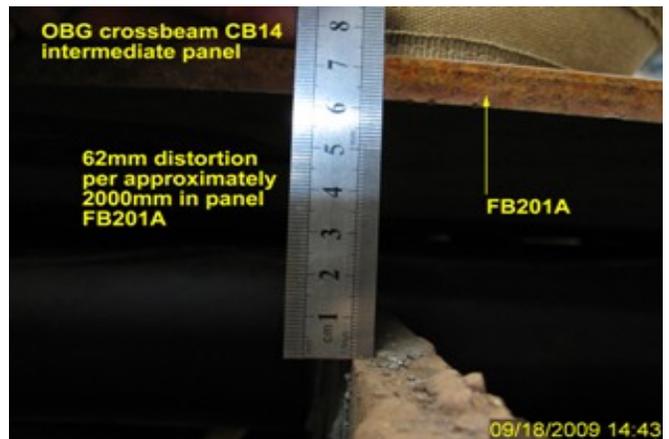
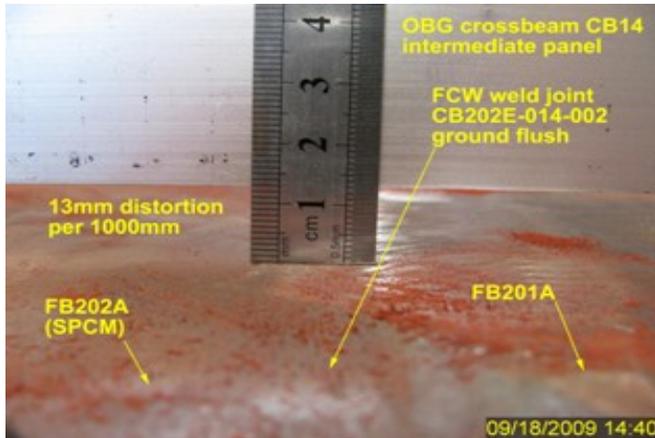
This QA observed that the contractor appeared to be “cold bending” Seismic Performance Critical Material (SPCM) and a Fracture Critical Weld (FCW). This QA observed two three (3) ton weights had been placed on the material, one on each side of the FCW. The weights appeared to be for the purpose of bending the material. This QA asked ZPMC QC CWI identified as Mr. Chen Xi why the weights were placed on this material. Mr. Chen informed this QA that the workers placed them there to get them out of the way for another project in this bay. This QA requested that the weights be removed from the material. Mr. Chen instructed the workers to remove the weights. After the weights were removed the material exhibited severe distortion. This QA informed Mr. Chen Xi and ABF inspector identified as Mr. Wang Wen Bin that an incident report would be generated for cold bending SPCM. AWS D1.5 2002 section 12.12 states “Cold bending shall be prohibited for all fracture critical steels”. The SPCM is identified as FB202A. The FCW joint is identified as CB202E-014-002. See attached photos for details.
