**DEPARTMENT OF TRANSPORTATION**

Contract #: 04-0120F4Cty: SF/ALA Rte: 80 PM: 13.2/13.9File #: 69.28**WELDING INSPECTION REPORT****Resident Engineer:** Pursell, Gary**Address:** 333 Burma Road**City:** Oakland, CA 94607**Report No:** WIR-009147**Date Inspected:** 21-Sep-2009**Project Name:** SAS Superstructure**OSM Arrival Time:** 700**Prime Contractor:** American Bridge/Fluor Enterprises, a JV**OSM Departure Time:** 1900**Contractor:** Zhenhua Port Machinery Company, Ltd (ZPMC), Changxing Island **Location:** Shanghai, China**CWI Name:** Liu Fa Wen**CWI Present:** Yes No**Inspected CWI report:** Yes No N/A**Rod Oven in Use:** Yes No N/A**Electrode to specification:** Yes No N/A**Weld Procedures Followed:** Yes No N/A**Qualified Welders:** Yes No N/A**Verified Joint Fit-up:** Yes No N/A**Approved Drawings:** Yes No N/A**Approved WPS:** Yes No N/A**Delayed / Cancelled:** Yes No N/A**Bridge No:** 34-0006**Component:** OBG Crossbeams**Summary of Items Observed:**

## WELDING INSPECTION REPORT

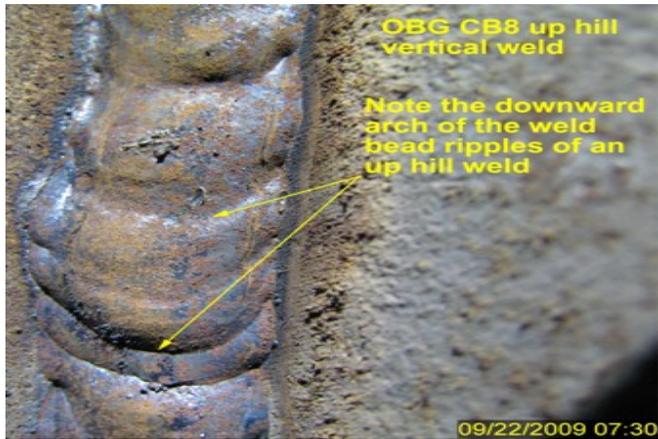
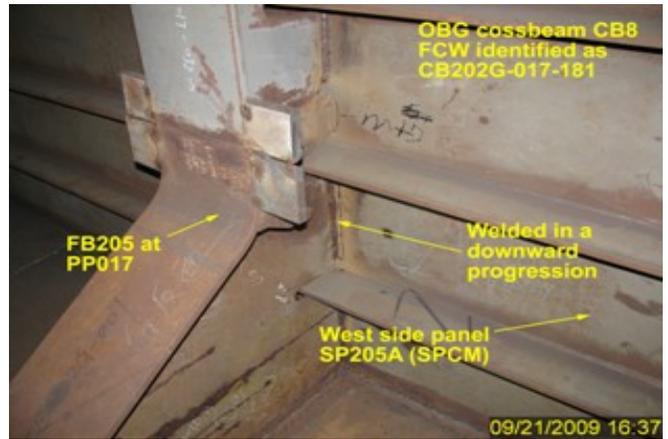
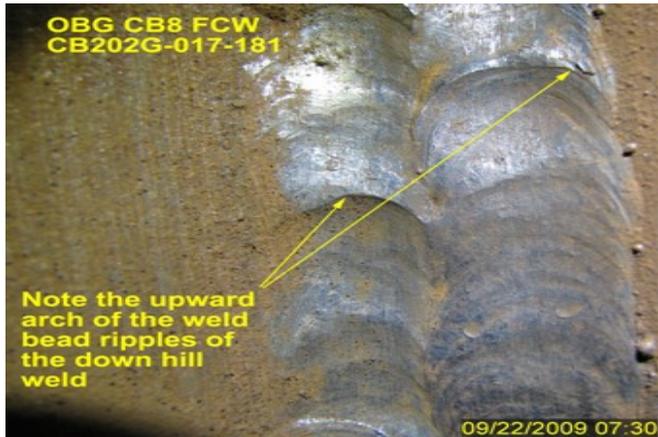
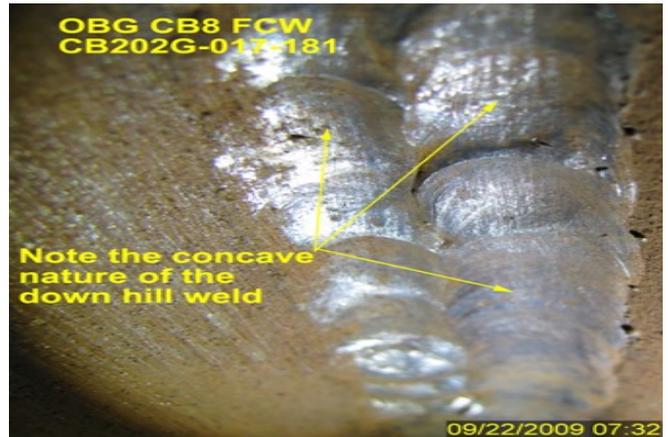
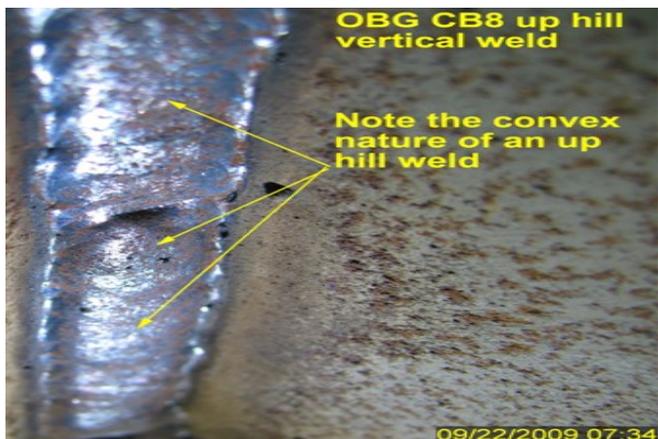
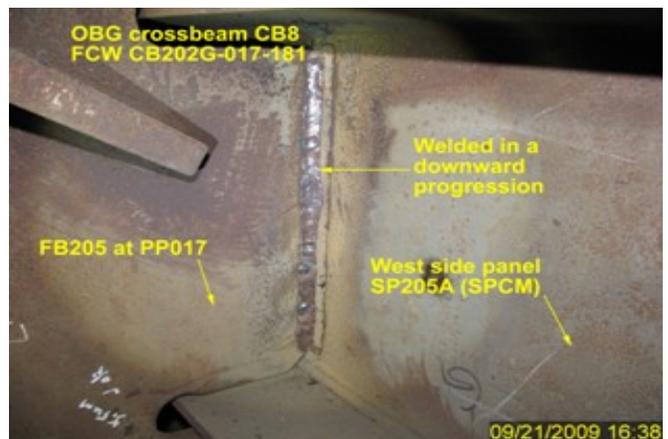
During random in process Visual Testing (VT) of the above mentioned crossbeam this Quality Assurance Inspector (QA) observed that the contractors welding personnel appears to have performed a vertical weld in a downward progression. The weld appeared to exhibit typical visual characteristics of a weld performed in a downward progression. The weld is identified as a Fracture Critical Weld (FCW) on the approved drawings. The weld is identified as CB202G-017-181. AWS D1.5 2002 section 4.6.8 states "The progression for all passes in the vertical position shall be upward, unless a downward progression is qualified by tests approved by the Engineer". This QA informed ABF inspector identified as Mr. Chang Bao Qian and ZPMC QC identified as Mr. Liu Fa Wen that an incident report will be generated for this issue. See attached photos.
