DEPARTMENT OF TRANSPORTATION

Quality Assurance and Source Inspection

Contract #: 04-0120F4Cty: SF/ALA Rte: 80 PM: 13.2/13.9File #: 69.28**WELDING INSPECTION REPORT****Resident Engineer:** Pursell, Gary**Address:** 333 Burma Road**City:** Oakland, CA 94607**Report No:** WIR-009391**Date Inspected:** 02-Oct-2009**Project Name:** SAS Superstructure**OSM Arrival Time:** 1900**Prime Contractor:** American Bridge/Fluor Enterprises, a JV**OSM Departure Time:** 700**Contractor:** Zhenhua Port Machinery Company, Ltd (ZPMC), Changxing Island **Location:** Shanghai, China**CWI Name:** Li Ming,**CWI Present:** Yes No**Inspected CWI report:** Yes No N/A**Rod Oven in Use:** Yes No N/A**Electrode to specification:** Yes No N/A**Weld Procedures Followed:** Yes No N/A**Qualified Welders:** Yes No N/A**Verified Joint Fit-up:** Yes No N/A**Approved Drawings:** Yes No N/A**Approved WPS:** Yes No N/A**Delayed / Cancelled:** Yes No N/A**Bridge No:** 34-0006**Component:** Tower/OBG**Summary of Items Observed:**

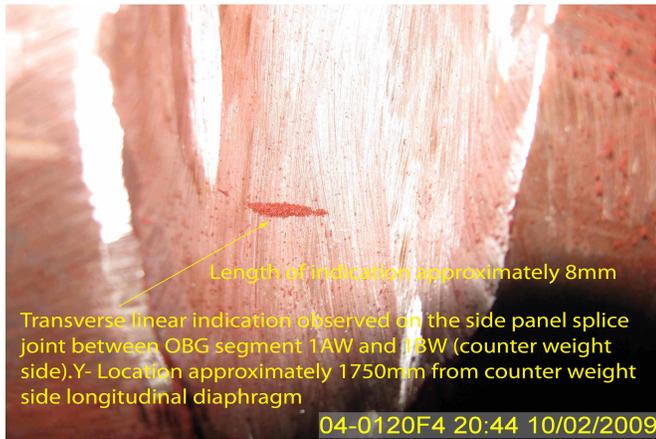
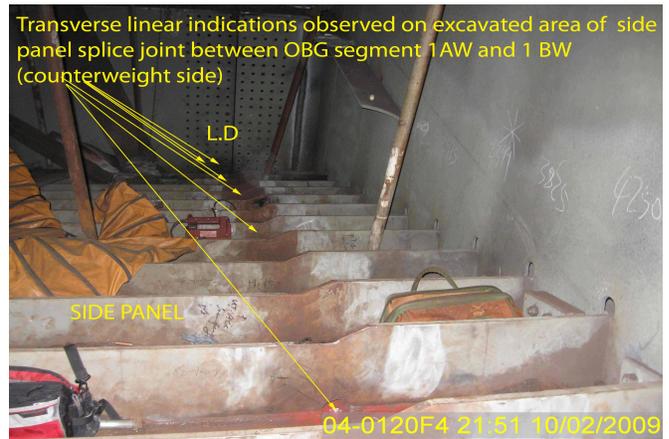
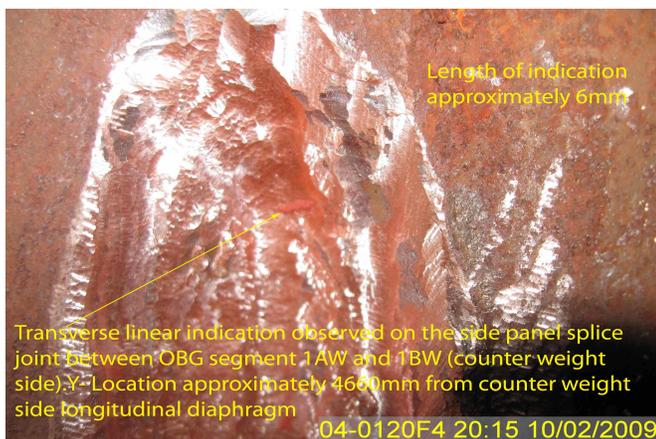
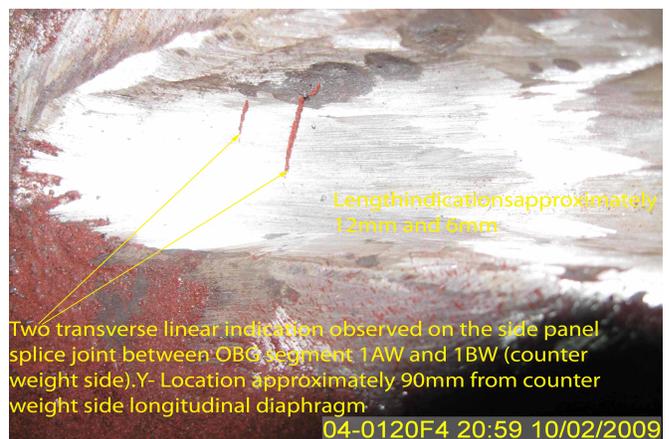
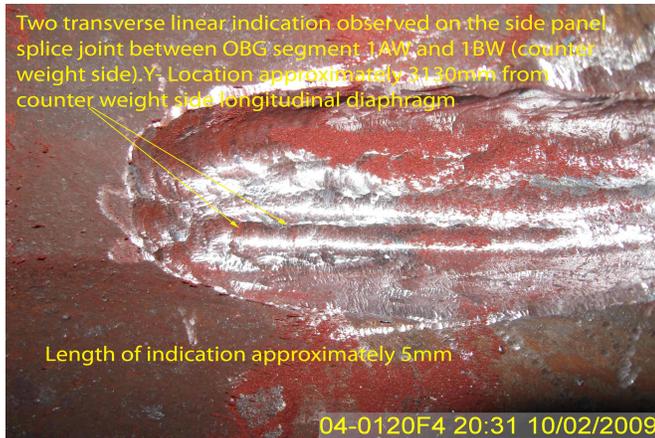
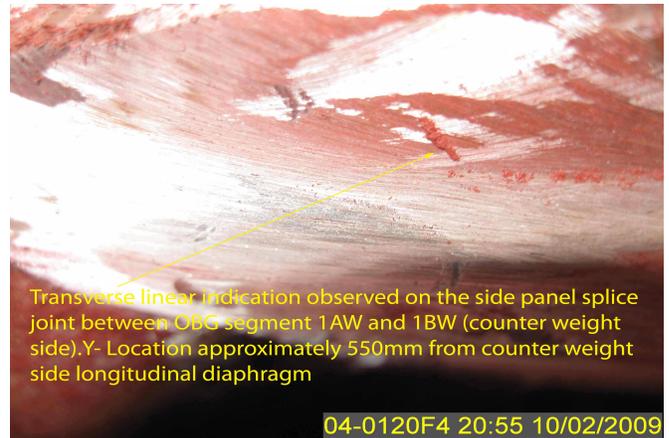
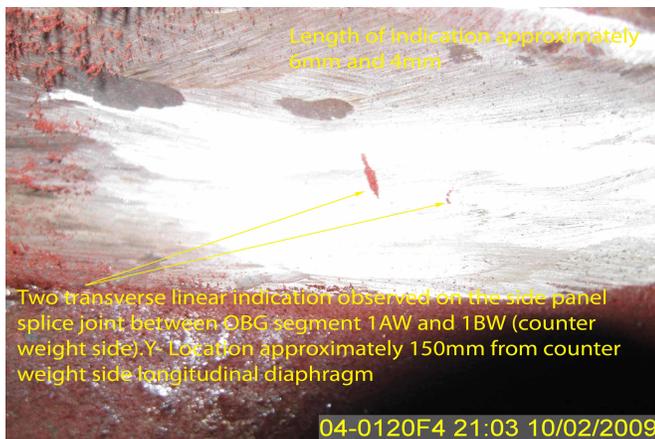
During the random visual inspection this QA Inspector observed the side panel splice joint between OBG segment 1AW and 1BW (counter weight side) observed excavated on various location by ZPMC personnel. This QA Inspector performed magnetic particle inspection over excavated area. During the magnetic particle inspection this QA Inspector found 9 transverse indications. Regarding this issue this QA Inspector informed to task leader and other supervisor. For additional information see photos below.
