DEPARTMENT OF TRANSPORTATION

Quality Assurance and Source Inspection

Contract #: 04-0120F4Cty: SF/ALA Rte: 80 PM: 13.2/13.9File #: 69.28**WELDING INSPECTION REPORT****Resident Engineer:** Pursell, Gary**Address:** 333 Burma Road**City:** Oakland, CA 94607**Report No:** WIR-010263**Date Inspected:** 04-Nov-2009**Project Name:** SAS Superstructure**OSM Arrival Time:** 700**Prime Contractor:** American Bridge/Fluor Enterprises, a JV**OSM Departure Time:** 1900**Contractor:** Zhenhua Port Machinery Company, Ltd (ZPMC), Changxing Island **Location:** Shanghai, China

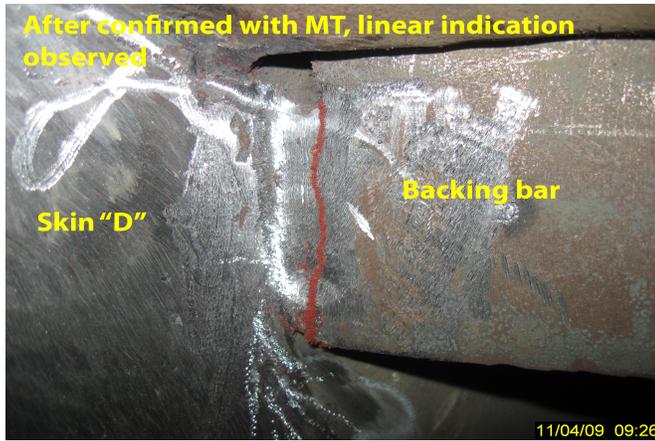
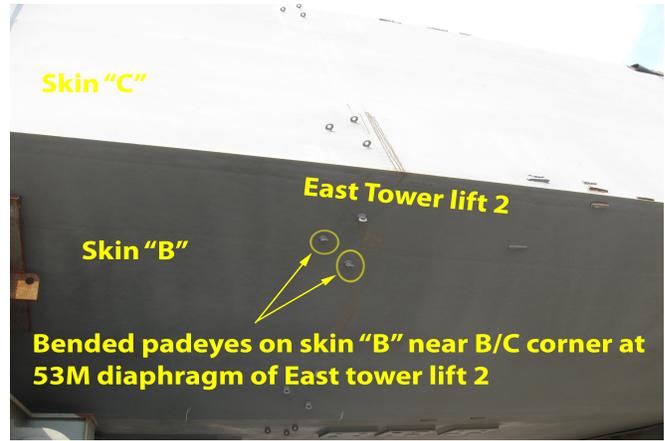
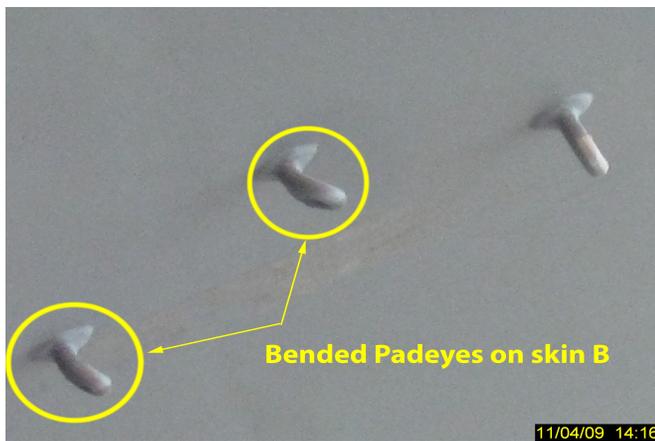
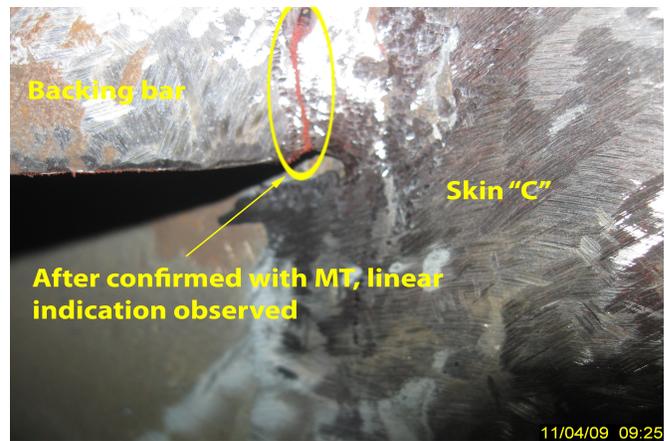
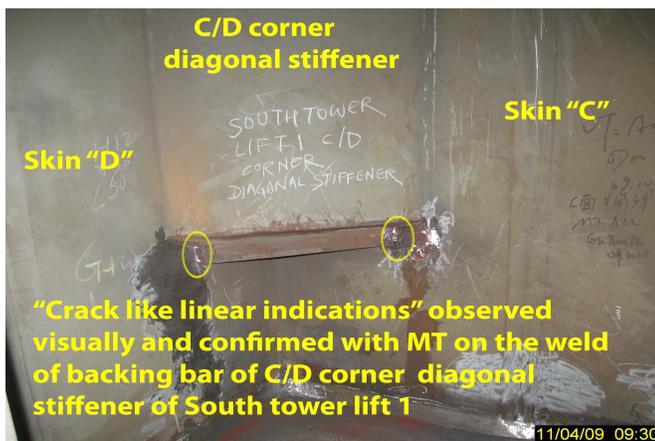
During random in process Visual Testing (VT) of South Tower Lift 1, backing bar of C/D corner diagonal stiffener located in the Tower assembly yard (Jetty Area), Caltrans Quality Assurance (QA) Inspector observed “crack like” linear indications on the backing bar of C/D corner diagonal stiffener fit for plate splice. This QA Inspector performed follow up Magnetic Particle Testing (MT) to confirm these linear indications. This issue has an incident report. The attached photographs provide additional detail.

During random in process Visual Testing (VT) of East Tower Lift 2 located in the Milling section, Caltrans Quality Assurance (QA) Inspector observed two padeyes on skin B near B/C corner bended at 53M diaphragm. The attached photographs provide additional detail.
