DEPARTMENT OF TRANSPORTATION

Quality Assurance and Source Inspection

Contract #: 04-0120F4Cty: SF/ALA Rte: 80 PM: 13.2/13.9File #: 69.28**WELDING INSPECTION REPORT****Resident Engineer:** Pursell, Gary**Address:** 333 Burma Road**City:** Oakland, CA 94607**Report No:** WIR-010421**Date Inspected:** 18-Nov-2009**Project Name:** SAS Superstructure**OSM Arrival Time:** 645**Prime Contractor:** American Bridge/Fluor Enterprises, a JV**OSM Departure Time:** 1845**Contractor:** Zhenhua Port Machinery Company, Ltd (ZPMC), Changxing Island **Location:** Shanghai, China**CWI Name:** Liu Fawen**CWI Present:** Yes No**Inspected CWI report:** Yes No N/A**Rod Oven in Use:** Yes No N/A**Electrode to specification:** Yes No N/A**Weld Procedures Followed:** Yes No N/A**Qualified Welders:** Yes No N/A**Verified Joint Fit-up:** Yes No N/A**Approved Drawings:** Yes No N/A**Approved WPS:** Yes No N/A**Delayed / Cancelled:** Yes No N/A**Bridge No:** 34-0006**Component:** Orthotropic Box Girder Components**Summary of Items Observed:**

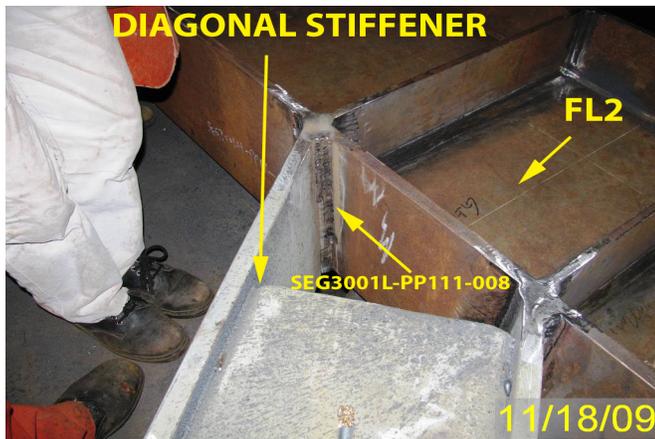
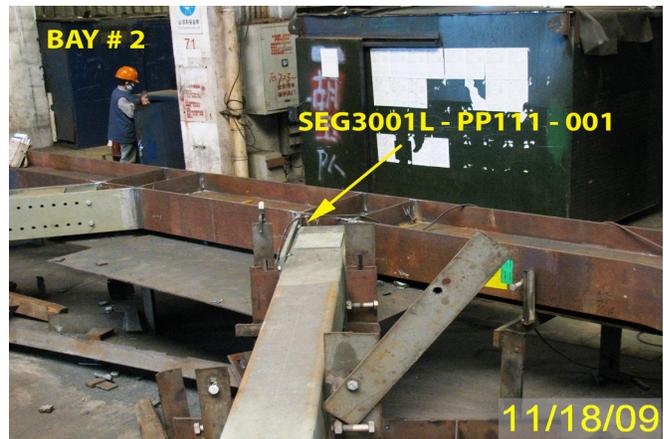
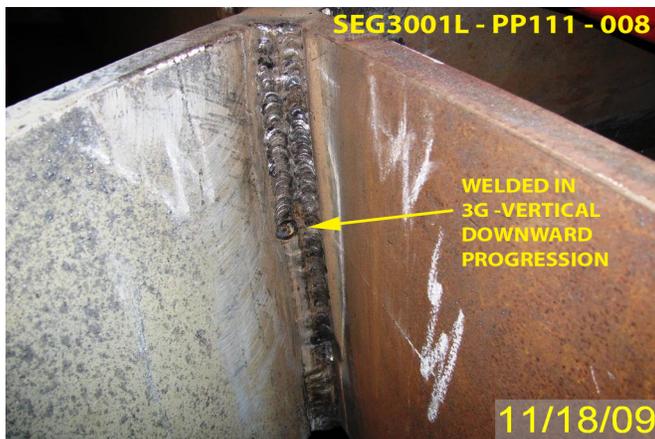
During random in-process visual inspection on Orthotropic Box Girder Floor Beams in Bay # 2, this Caltrans Quality Assurance (QA) Inspector observed ZPMC personnel performing Shielded Metal Arc Welding (SMAW) repair of weld joint identified as Complete Joint Penetration (CJP) SEG3001L-PP111-008. Welding was observed being performed in the 3G position with a vertical downward progression which does not comply with the applicable repair Welding Procedure Specification WPS-345-SMAW-3G (3F)-Repair.

AWS D1.5 2002 section 4.6.8: “The progression for all passes in the vertical position shall be upward, unless a downward progression is qualified by tests approved by the Engineer”.

Approved Repair WPS # WPS-345-SMAW-3G (3F)-Repair: “Welding Progression – Vertical – Up Direction”

This QA notified ZPMC CWI identified as Mr.Chen Xi and ABF inspector identified as Mr. Luo Gui Lin of the above issue and that an incident report will be generated.
