**DEPARTMENT OF TRANSPORTATION**

Contract #: 04-0120F4Cty: SF/ALA Rte: 80 PM: 13.2/13.9File #: 69.28**WELDING INSPECTION REPORT****Resident Engineer:** Pursell, Gary**Address:** 333 Burma Road**City:** Oakland, CA 94607**Report No:** WIR-011566**Date Inspected:** 22-Jan-2010**Project Name:** SAS Superstructure**OSM Arrival Time:** 645**Prime Contractor:** American Bridge/Fluor Enterprises, a JV**OSM Departure Time:** 1845**Contractor:** Zhenhua Port Machinery Company, Ltd (ZPMC), Changxing Island **Location:** Shanghai, China**CWI Name:** Liu Fawen**CWI Present:** Yes No**Inspected CWI report:** Yes No N/A**Rod Oven in Use:** Yes No N/A**Electrode to specification:** Yes No N/A**Weld Procedures Followed:** Yes No N/A**Qualified Welders:** Yes No N/A**Verified Joint Fit-up:** Yes No N/A**Approved Drawings:** Yes No N/A**Approved WPS:** Yes No N/A**Delayed / Cancelled:** Yes No N/A**Bridge No:** 34-0006**Component:** Orthotropic Box Girder (OBG) Components**Summary of Items Observed:**

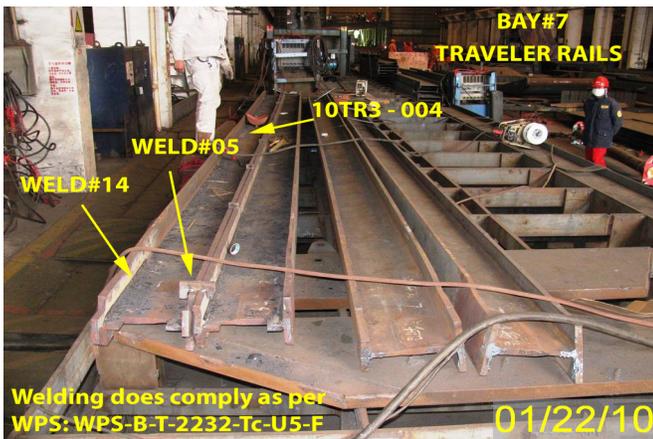
See attached photo:-

Unless otherwise noted, all work observed on this date appeared to generally comply with applicable contract documents.
