Contract #: 04-0120F4Cty: SF/ALA Rte: 80 PM: 13.2/13.9File #: 69.28**WELDING INSPECTION REPORT****Resident Engineer:** Pursell, Gary**Address:** 333 Burma Road**City:** Oakland, CA 94607**Report No:** WIR-011653**Date Inspected:** 25-Jan-2010**Project Name:** SAS Superstructure**OSM Arrival Time:** 700**Prime Contractor:** American Bridge/Fluor Enterprises, a JV**OSM Departure Time:** 1900**Contractor:** Zhenhua Port Machinery Company, Ltd (ZPMC), Changxing Island **Location:** Shanghai, China

CWI Name:	N/A	CWI Present:	Yes	No
Inspected CWI report:	Yes No N/A	Rod Oven in Use:	Yes No N/A	
Electrode to specification:	Yes No N/A	Weld Procedures Followed:	Yes No N/A	
Qualified Welders:	Yes No N/A	Verified Joint Fit-up:	Yes No N/A	
Approved Drawings:	Yes No N/A	Approved WPS:	Yes No N/A	
		Delayed / Cancelled:	Yes No N/A	
Bridge No:	34-0006	Component:	Orthotropic Box Girder (OBG)

OBG TRIAL ASSEMBLY

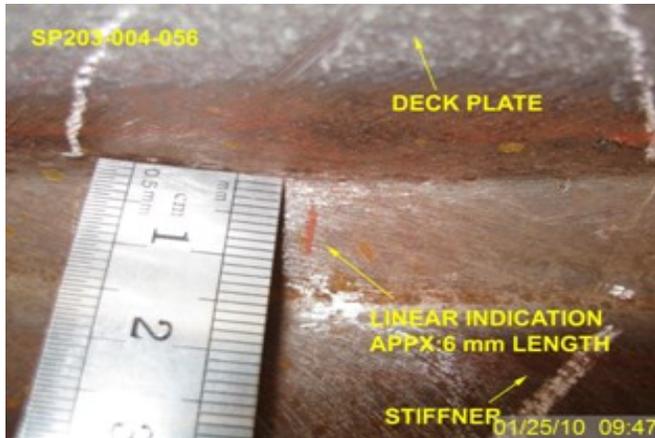
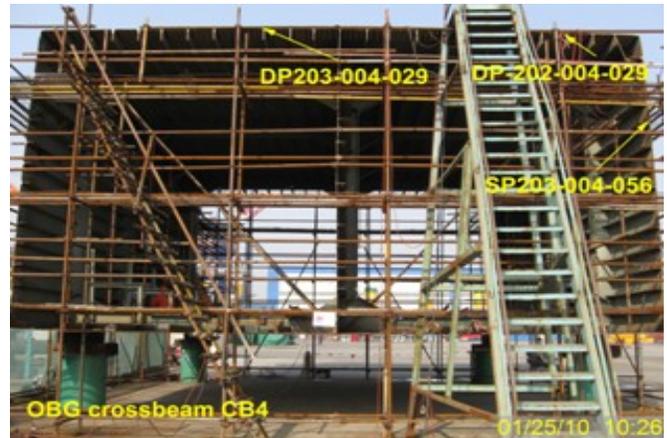
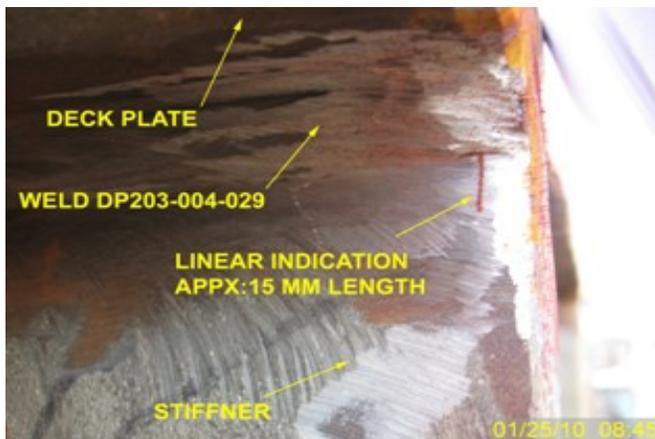
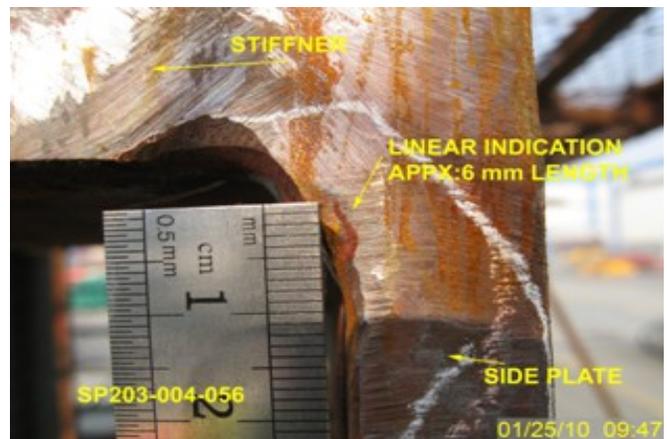
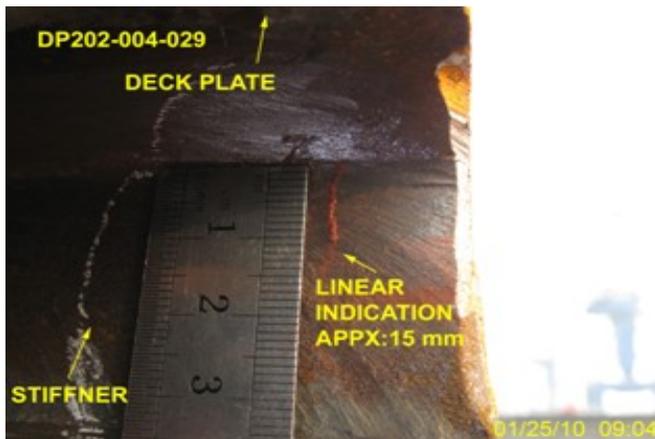
During Quality Assurance Magnetic Particle Testing (MT) review of welds located on Cross Beam CB4, this Quality Assurance Inspector (QA) discovered the following issues:

- One (1) Transverse Linear indication measuring approximately 15 mm in length.
- The weld is identified as: DP202-004-029.
- The weld is a fillet weld joining deck plate to stiffener plate.
- One (1) Transverse Linear indication measuring approximately 15 mm in length.
- The weld is identified as: DP203-004-029.
- The weld is a fillet weld joining deck plate to stiffener plate.
- Two (2) Transverse Linear indications measuring approximately each indication 6 mm in length.
- The weld is identified as: SP203-004-056.
- The weld is a fillet weld joining deck plate to stiffener plate.
- CB4 is located near the OBG TRIAL ASSEMBLY AREA.

The Notice of Witness Inspection Number (NWIT) is 005123. The indications are located outside the area that has been previously tested and accepted by ZPMC Quality Control (QC) personnel. As per the contract documents,

ZPMC's QC personnel are required to perform 25% MT inspection of these welds.

This QA notified ZPMC QC identified as Mr. Wang Li Yang and ABF inspector identified as Mr. Zouhu of the above issue and that an incident report will be generated.
