Contract #: 04-0120F4Cty: SF/ALA Rte: 80 PM: 13.2/13.9File #: 69.28**WELDING INSPECTION REPORT****Resident Engineer:** Pursell, Gary**Address:** 333 Burma Road**City:** Oakland, CA 94607**Report No:** WIR-011717**Date Inspected:** 26-Jan-2010**Project Name:** SAS Superstructure**OSM Arrival Time:** 700**Prime Contractor:** American Bridge/Fluor Enterprises, a JV**OSM Departure Time:** 1900**Contractor:** Zhenhua Port Machinery Company, Ltd (ZPMC), Changxing Island **Location:** Shanghai, China**CWI Name:** Mr. Li Yang**CWI Present:** Yes No**Inspected CWI report:** Yes No N/A**Rod Oven in Use:** Yes No N/A**Electrode to specification:** Yes No N/A**Weld Procedures Followed:** Yes No N/A**Qualified Welders:** Yes No N/A**Verified Joint Fit-up:** Yes No N/A**Approved Drawings:** Yes No N/A**Approved WPS:** Yes No N/A**Delayed / Cancelled:** Yes No N/A**Bridge No:** 34-0006**Component:** Orthotropic Box Girder (OBG)**Summary of Items Observed:**

**OBG TRIAL ASSEMBLY**

**SEGMENT- 7BE-7CE**

**SEGMENT-CB4**

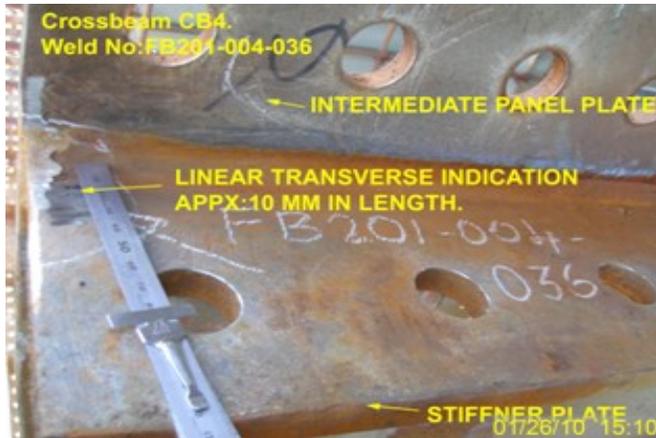
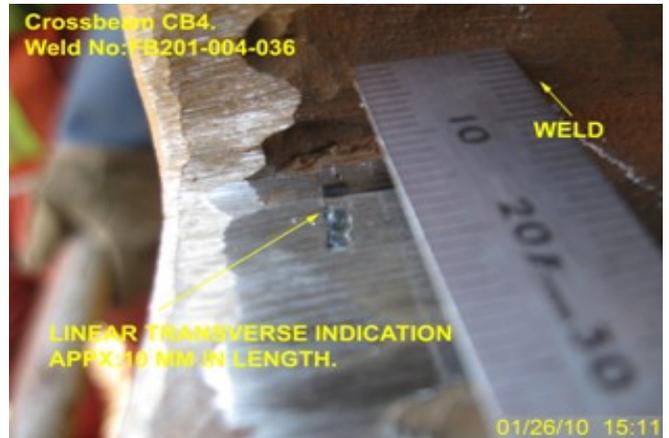
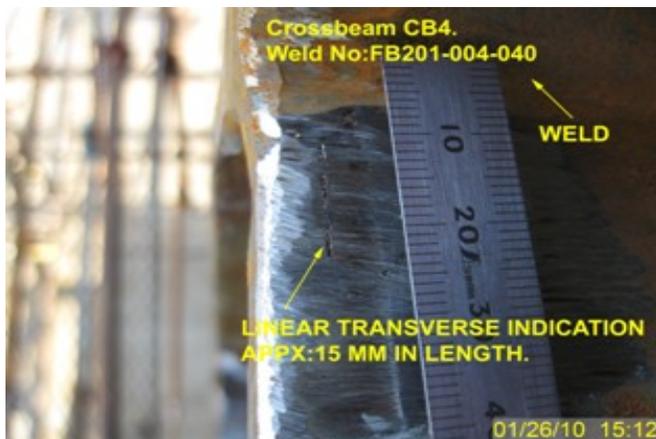
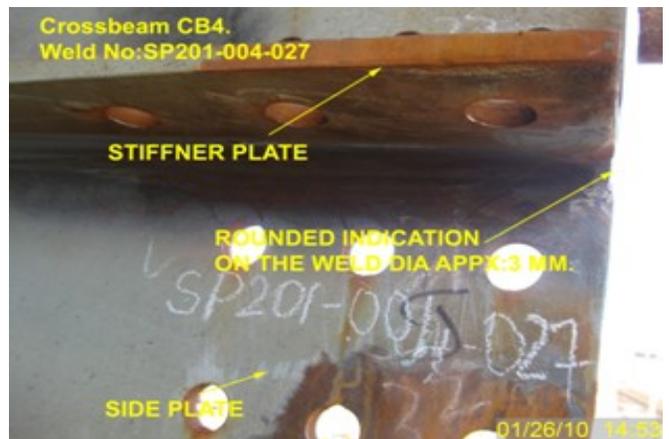
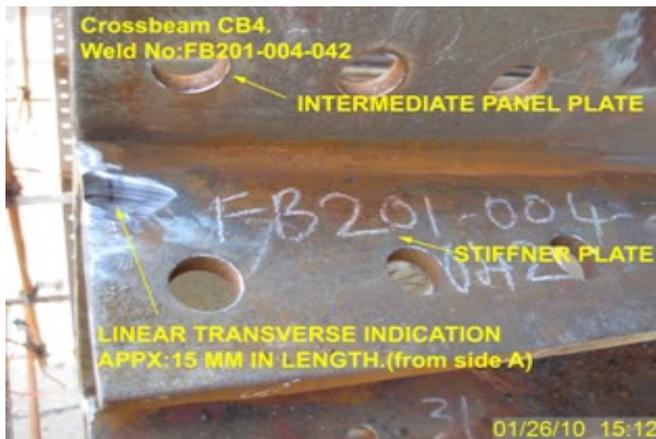
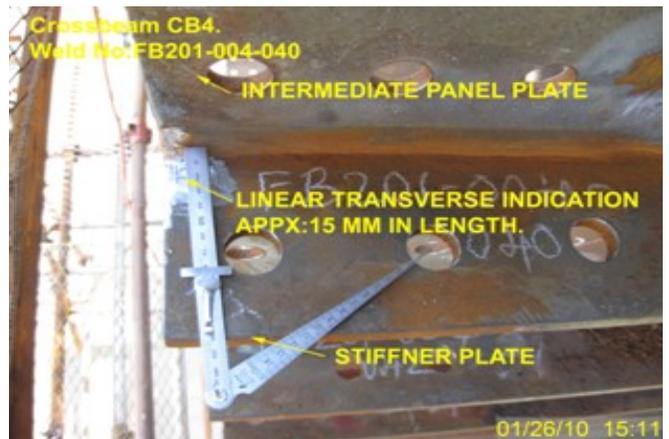
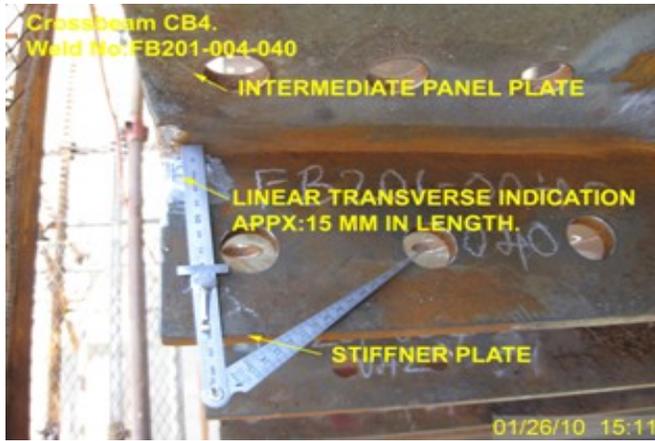
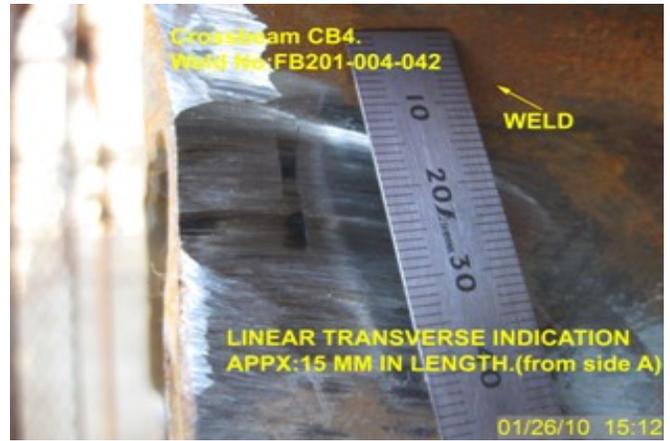
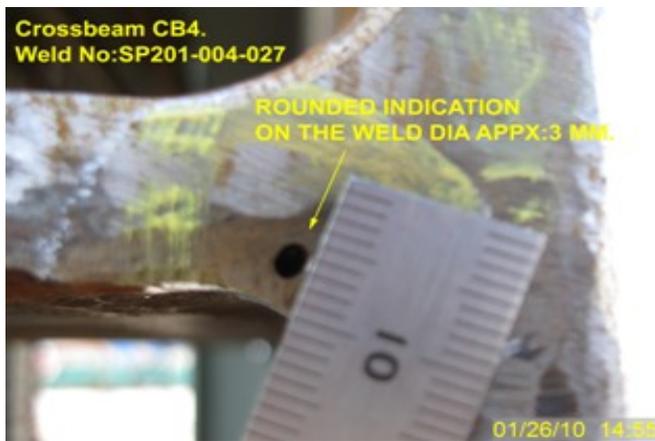
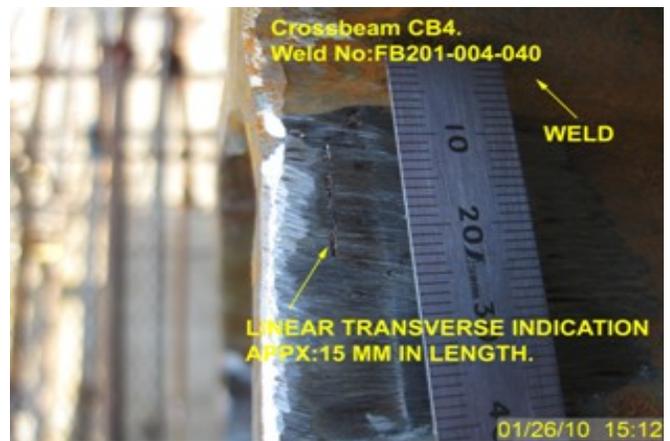
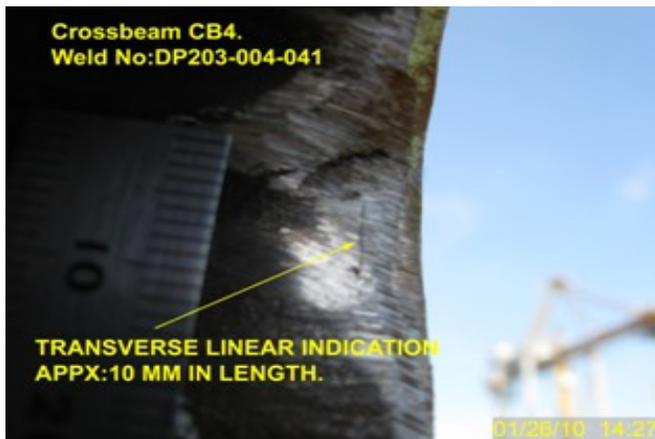
During Quality Assurance VT review of welds located on Cross Beam CB4, this Quality Assurance Inspector (QA) discovered the following issues:

- One (1) Transverse Linear indication on base material measuring approximately 08 mm in length.
- The nearest weld to the indication is identified as: DP203-004-o41.
- The weld is a fillet weld joining deck plate to stiffener plate.

- One (1) Rounded indication on weld measuring approximately 3.0 mm dia.
- The weld is identified as: SP201-004-027.
- The weld is a fillet weld joining deck plate to stiffener plate.

- One (1) Transverse Linear indication on base material measuring approximately 10 mm in length.
- The nearest weld to the indication is identified as: FB201-004-036.
- The weld is a fillet weld joining deck plate to stiffener plate.

- One (1) Transverse Linear indication on base material measuring approximately 15 mm in length.
- The nearest weld to the indication is identified as: FB201-004-040.
- The weld is a fillet weld joining deck plate to stiffener plate.

- One (1) Transverse Linear indication on base material measuring approximately 15 mm in length.
- The nearest weld to the indication is identified as: FB201-004-042.
- The weld is a fillet weld joining deck plate to stiffener plate.

The attached photographs provide additional detail.

This QA notified ZPMC QC identified as Mr.Wang Li Yang and ABF inspector identified as Mr. Ding and Mr. Zhuhu of the above issue, and reported to the Team leader for further action.
