Contract #: 04-0120F4Cty: SF/ALA Rte: 80 PM: 13.2/13.9File #: 69.28**WELDING INSPECTION REPORT****Resident Engineer:** Pursell, Gary**Address:** 333 Burma Road**City:** Oakland, CA 94607**Report No:** WIR-011799**Date Inspected:** 05-Feb-2010**Project Name:** SAS Superstructure**OSM Arrival Time:** 1900**Prime Contractor:** American Bridge/Fluor Enterprises, a JV**OSM Departure Time:** 700**Contractor:** Zhenhua Port Machinery Company, Ltd (ZPMC), Changxing Island **Location:** Shanghai, China**CWI Name:** See Below**CWI Present:** Yes No**Inspected CWI report:** Yes No N/A**Rod Oven in Use:** Yes No N/A**Electrode to specification:** Yes No N/A**Weld Procedures Followed:** Yes No N/A**Qualified Welders:** Yes No N/A**Verified Joint Fit-up:** Yes No N/A**Approved Drawings:** Yes No N/A**Approved WPS:** Yes No N/A**Delayed / Cancelled:** Yes No N/A**Bridge No:** 34-0006**Component:** OBG**Summary of Items Observed:**

OBG Trial Assembly

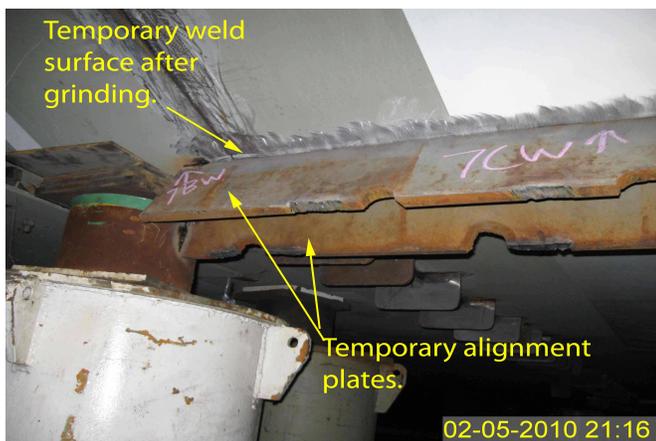
This QA Inspector observed ZPMC welder Mr. Ji Yi, stencil 045268 is preparing to use shielded metal arc procedure WPS-B-P-2214-TC-U4b-FCM-1 to tack weld two temporary plates to the cross beam side of OBG segments 7BW and 7CW. This plate appears to be intended to maintain alignment of the two OBG segments as the various weld joints are brought into alignment. See the photograph below for additional information. This QA Inspector observed the area that was being preheated prior to welding appears to have been partially ground to remove paint and several areas where tack welds are to be made have not had all the paint removed. This QA Inspector informed ZPMC CWI Mr. Li Yang that AWS D1.5 requires all base material that is to be welded needs to be cleaned to a "Bright metal" condition and this surface needs to have all the paint removed. Mr. Li Yang had the front surface of the base material ground and when ZPMC started to preheat the back side of the plate this QA Inspector showed Mr. Li Yan several other areas on the back side of the temporary plate where the paint has not been removed. Mr. Li Yang had this area ground prior to commencement of the tack welding.
