Contract #: 04-0120F4Cty: SF/ALA Rte: 80 PM: 13.2/13.9File #: 69.28**WELDING INSPECTION REPORT****Resident Engineer:** Pursell, Gary**Address:** 333 Burma Road**City:** Oakland, CA 94607**Report No:** WIR-012207**Date Inspected:** 23-Feb-2010**Project Name:** SAS Superstructure**OSM Arrival Time:** 700**Prime Contractor:** American Bridge/Fluor Enterprises, a JV**OSM Departure Time:** 1900**Contractor:** Zhenhua Port Machinery Company, Ltd (ZPMC), Changxing Island **Location:** Shanghai, China**CWI Name:** Li Yang**CWI Present:** Yes No**Inspected CWI report:** Yes No N/A**Rod Oven in Use:** Yes No N/A**Electrode to specification:** Yes No N/A**Weld Procedures Followed:** Yes No N/A**Qualified Welders:** Yes No N/A**Verified Joint Fit-up:** Yes No N/A**Approved Drawings:** Yes No N/A**Approved WPS:** Yes No N/A**Delayed / Cancelled:** Yes No N/A**Bridge No:** 34-0006**Component:** OBG**Summary of Items Observed:**

WELDING INSPECTION REPORT

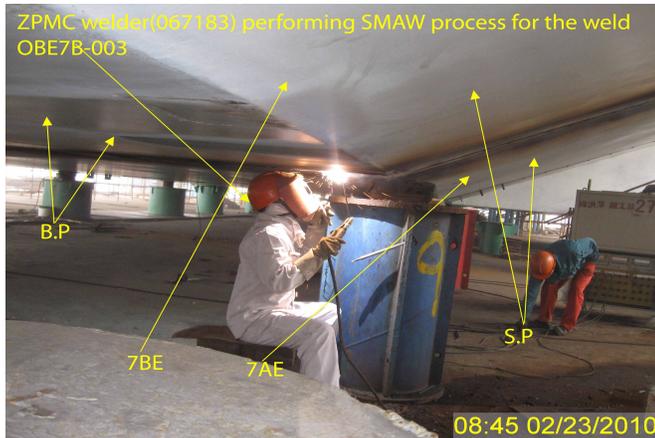
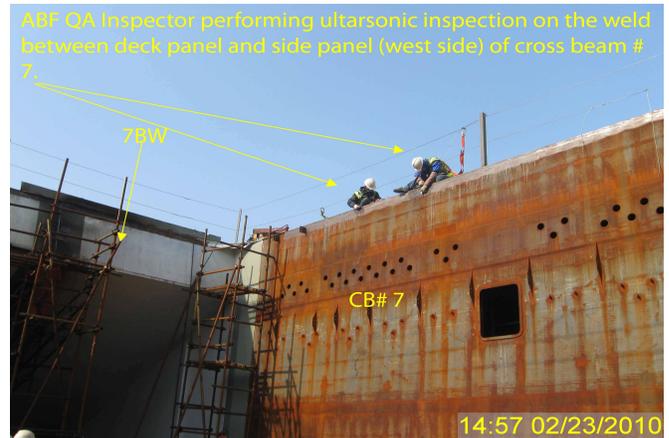
This Quality Assurance (QA) Inspector observed ABF QA Inspectors performing ultrasonic inspection on the weld between side panel and deck panel (west side). See attached photo.
