DEPARTMENT OF TRANSPORTATION

Contract #: 04-0120F4Cty: SF/ALA Rte: 80 PM: 13.2/13.9File #: 69.28**WELDING INSPECTION REPORT****Resident Engineer:** Pursell, Gary**Address:** 333 Burma Road**City:** Oakland, CA 94607**Report No:** WIR-012238**Date Inspected:** 18-Feb-2010**Project Name:** SAS Superstructure**OSM Arrival Time:** 645**Prime Contractor:** American Bridge/Fluor Enterprises, a JV**OSM Departure Time:** 1845**Contractor:** Zhenhua Port Machinery Company, Ltd (ZPMC), Changxing Island **Location:** Shanghai, China**CWI Name:** Li Yang**CWI Present:** Yes No**Inspected CWI report:** Yes No N/A**Rod Oven in Use:** Yes No N/A**Electrode to specification:** Yes No N/A**Weld Procedures Followed:** Yes No N/A**Qualified Welders:** Yes No N/A**Verified Joint Fit-up:** Yes No N/A**Approved Drawings:** Yes No N/A**Approved WPS:** Yes No N/A**Delayed / Cancelled:** Yes No N/A**Bridge No:** 34-0006**Component:** OBG COMPONENT**Summary of Items Observed:**

WELDING INSPECTION REPORT

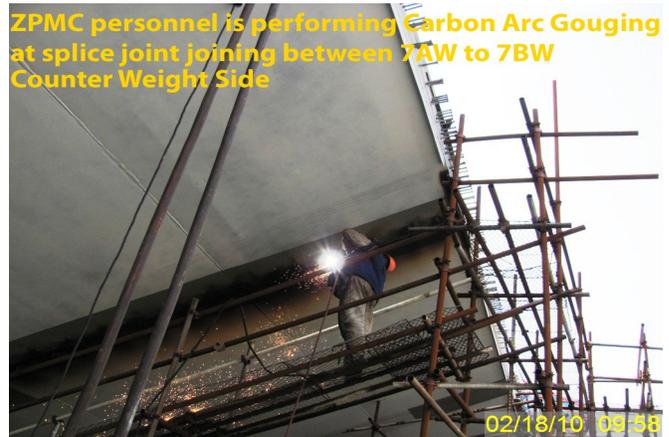
The QA Inspector observed that the ZPMC personnel is performing Carbon Arc Gouging from outside after welding from inside at side plate to side plate splice joint joining between 7AW to 7BW at Counter Weight Side.

The weld joint is identified as OBW7B-004.
