**DEPARTMENT OF TRANSPORTATION**

Contract #: 04-0120F4Cty: SF/ALA Rte: 80 PM: 13.2/13.9File #: 99.28**WELDING INSPECTION REPORT****Resident Engineer:** Pursell, Gary**Address:** 333 Burma Road**City:** Oakland, CA 94607**Report No:** WIR-012335**Date Inspected:** 18-Feb-2010**Project Name:** SAS Superstructure**OSM Arrival Time:** 645**Prime Contractor:** American Bridge/Fluor Enterprises, a JV**OSM Departure Time:** 1845**Contractor:** Zhenhua Port Machinery Company, Ltd (ZPMC) Chanxing Island **Location:** Shanghai, China

<b>CWI Name:</b>	N/A	<b>CWI Present:</b>	Yes	No
<b>Inspected CWI report:</b>	Yes No N/A	<b>Rod Oven in Use:</b>	Yes No N/A	
<b>Electrode to specification:</b>	Yes No N/A	<b>Weld Procedures Followed:</b>	Yes No N/A	
<b>Qualified Welders:</b>	Yes No N/A	<b>Verified Joint Fit-up:</b>	Yes No N/A	
<b>Approved Drawings:</b>	Yes No N/A	<b>Approved WPS:</b>	Yes No N/A	
		<b>Delayed / Cancelled:</b>	Yes No N/A	
<b>Bridge No:</b>	34-0006	<b>Component:</b>	OBG Segment 10BE

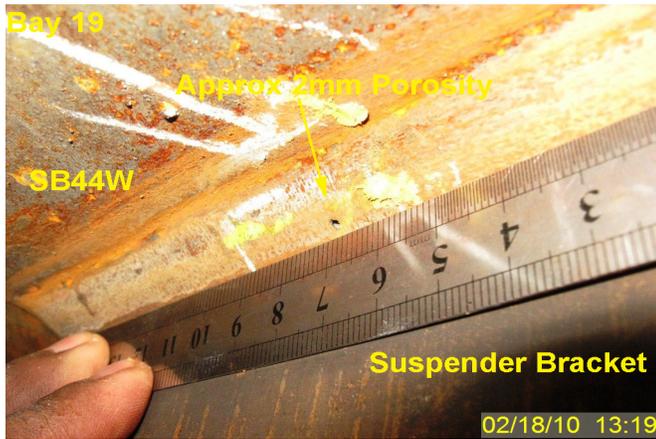
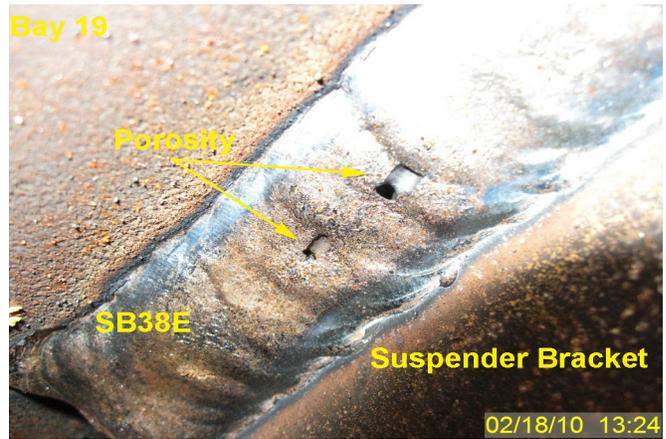
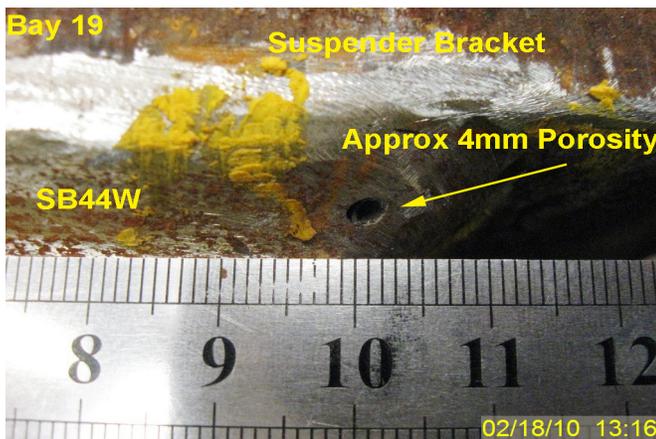
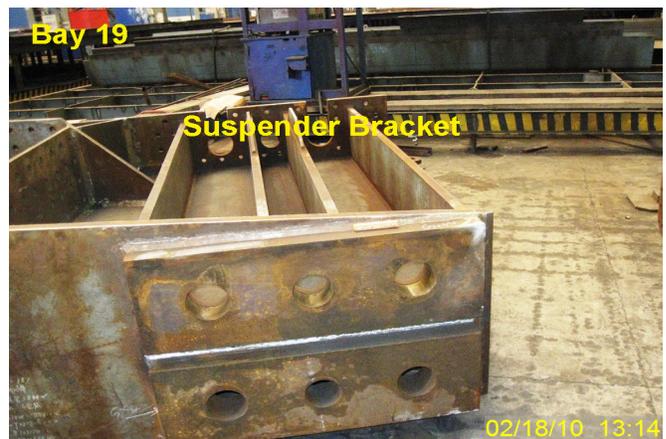
During random Quality Assurance visual review of welds located bay-19 on Suspender Brackets, this Quality Assurance Inspector (QA) discovered four (4) porosities, that measuring approximately 1.5 to 3mm in diameter. The indication is clearly marked on the material near the weld. The Suspender Brackets are identified as SB44W and SB38E. The Suspender Bracket weld is identified as Non SPCM. For further information, please see the attached pictures

Caltrans Quality Assurance (QA) Inspectors performed random visual inspection of OBG segment 8CE interior Corner Assembly, Bottom Panel, Deck Panel, Floor Beam and Longitudinal Diaphragms surfaces from the panel point 67.5 to 69 after grit blasting and also carried out random visual inspection on segment 8CE exterior such as Bottom Panel, Deck Panel, and Side Panels. Areas that marked for repair were recorded for future repair. Areas requiring additional grinding were marked by QA and repaired by ZPMC personnel
