DEPARTMENT OF TRANSPORTATION

Quality Assurance and Source Inspection

Contract #: 04-0120F4Cty: SF/ALA Rte: 80 PM: 13.2/13.9File #: 69.28**WELDING INSPECTION REPORT****Resident Engineer:** Pursell, Gary**Address:** 333 Burma Road**City:** Oakland, CA 94607**Report No:** WIR-012607**Date Inspected:** 14-Feb-2010**Project Name:** SAS Superstructure**OSM Arrival Time:** 700**Prime Contractor:** American Bridge/Fluor Enterprises, a JV**OSM Departure Time:** 1500**Contractor:** Zhenhua Port Machinery Company, Ltd (ZPMC), Changxing Island **Location:** Shanghai, China

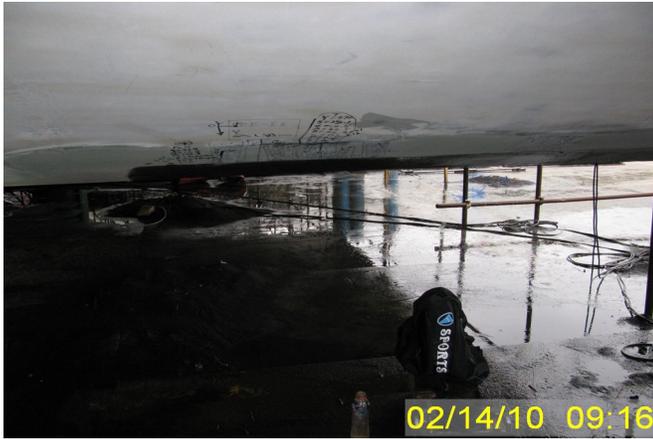
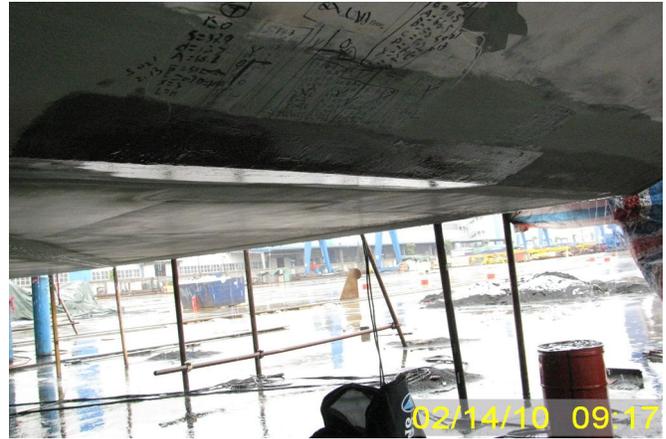
This QA Inspector performed Conventional Ultrasonic inspection, UT, on OBG segment 5CE, Bottom Plate to Side Plate, at location E3. This inspection was performed in accordance with the current "D" scan procedure, and in cooperation with ABF after weld repair by ZPMC. Indications were found by ABF, and verified by this inspector. No additional indications were noted. For more information on this inspection, see the ABF UT report for this date.
