Contract #: 04-0120F4Cty: SF/ALA Rte: 80 PM: 13.2/13.9File #: 69.28**WELDING INSPECTION REPORT****Resident Engineer:** Pursell, Gary**Address:** 333 Burma Road**City:** Oakland, CA 94607**Report No:** WIR-012410**Date Inspected:** 04-Mar-2010**Project Name:** SAS Superstructure**OSM Arrival Time:** 1900**Prime Contractor:** American Bridge/Fluor Enterprises, a JV**OSM Departure Time:** 700**Contractor:** Zhenhua Port Machinery Company, Ltd (ZPMC), Changxing Island **Location:** Shanghai, China**CWI Name:** See Below**CWI Present:** Yes No**Inspected CWI report:** Yes No N/A**Rod Oven in Use:** Yes No N/A**Electrode to specification:** Yes No N/A**Weld Procedures Followed:** Yes No N/A**Qualified Welders:** Yes No N/A**Verified Joint Fit-up:** Yes No N/A**Approved Drawings:** Yes No N/A**Approved WPS:** Yes No N/A**Delayed / Cancelled:** Yes No N/A**Bridge No:** 34-0006**Component:** OBG and Tower**Summary of Items Observed:**

WELDING INSPECTION REPORT

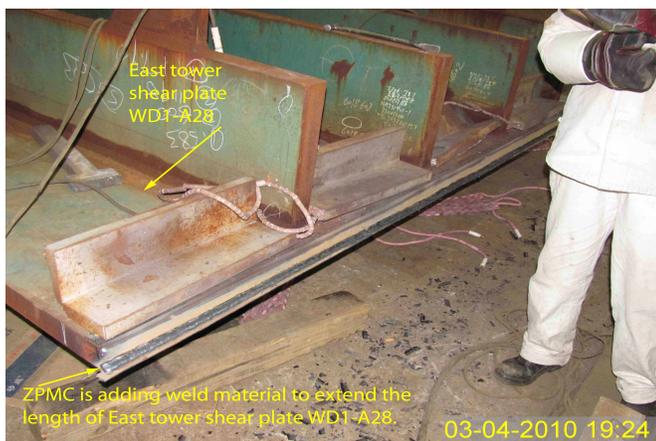
This QA Inspector observed ZPMC welder Ms. Bu Xuezhen stencil 052075 is using flux cored welding procedure WPS-345-FCAW-3G(3F)-Repair to add weld material and extend the length of East tower shear plate WD1-A28 in accordance with weld repair document TWR-3081. This QA Inspector observed a welding current of approximately 230 amps and 26.0 volts. This QA Inspector observed ZPMC has electrical heating elements to maintain the base material temperature and ZPMC QC personnel are monitoring the interpass temperature to ensure the base material is an acceptable temperature. Items observed on this date appeared to generally comply with applicable contract documents. See the photograph below for additional information.

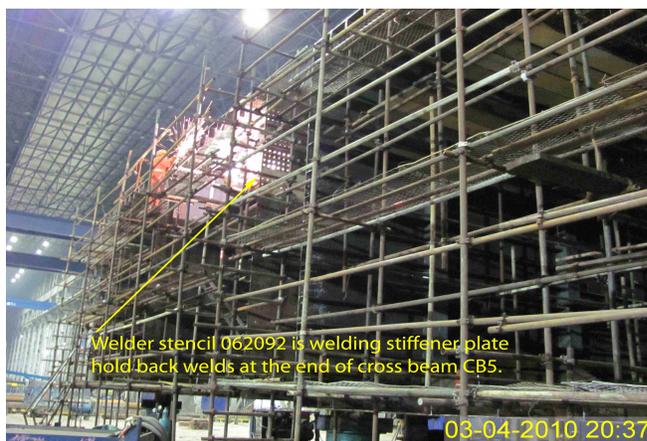
This QA Inspector observed ZPMC welder Mr. Hu Yanming, stencil 062092 is using shielded metal arc procedure WPS-345-SMAW-2G(2F)-Repair- to make repair welds to various stiffener hold back welds at the end of cross beam CB5. This QA Inspector observed the welding electrodes are being stored in a portable rod oven which is connected to an electric power cable. This QA Inspector observed the base material appears to have been preheated with a torch prior to commencement of welding. This QA Inspector measured a welding current of approximately 1805 amps and Mr. Hu Yanming appears to be certified to make this weld. Items observed on this date appeared to generally comply with applicable contract documents. See the photograph below for additional information.
