Contract #: 04-0120F4Cty: SF/ALA Rte: 80 PM: 13.2/13.9File #: 69.28**WELDING INSPECTION REPORT****Resident Engineer:** Pursell, Gary**Address:** 333 Burma Road**City:** Oakland, CA 94607**Report No:** WIR-020055**Date Inspected:** 20-Mar-2010**Project Name:** SAS Superstructure**OSM Arrival Time:** 700**Prime Contractor:** American Bridge/Fluor Enterprises, a JV**OSM Departure Time:** 1900**Contractor:** Zhenhua Port Machinery Company, Ltd (ZPMC), Changxing Island **Location:** Shanghai, China

CWI Name:	Liu Hua Jie, Lu Li Qing, Geng Wei			CWI Present:	Yes	No	
Inspected CWI report:	Yes	No	N/A	Rod Oven in Use:	Yes	No	N/A
Electrode to specification:	Yes	No	N/A	Weld Procedures Followed:	Yes	No	N/A
Qualified Welders:	Yes	No	N/A	Verified Joint Fit-up:	Yes	No	N/A
Approved Drawings:	Yes	No	N/A	Approved WPS:	Yes	No	N/A
				Delayed / Cancelled:	Yes	No	N/A
Bridge No:	34-0006			Component:	Orthotropic Box Girder (OBG)

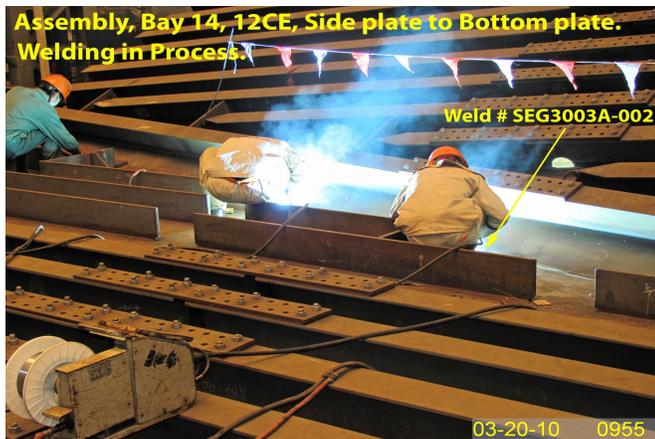
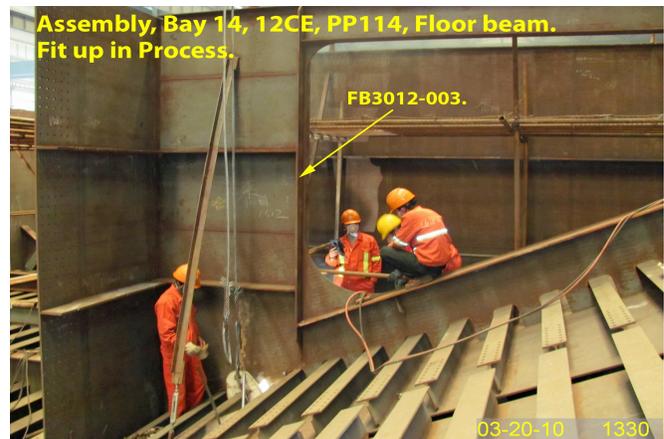
SMAW welding of weld joint SEG3003A-002; located on assembly, Bay 14, 12CE. Welder is identified as 044774, 058551; ZPMC Quality Control Inspector (QC) is identified as Geng Wei. The welding variables recorded by Quality Control Inspector (QC) appeared to comply with the Applicable WPS: WPS-B-T-2231-B-U2-F. The attached photographs provide additional detail.

During the Quality Assurance (QA) random in-process visual inspection, this QA inspector observed ZPMC Personnel performing fit up of Floor Beam Identified as FB3012-003. The attached photographs provide additional detail.
