DEPARTMENT OF TRANSPORTATION

Quality Assurance and Source Inspection

Contract #: 04-0120F4Cty: SF/ALA Rte: 80 PM: 13.2/13.9File #: 69.28**WELDING INSPECTION REPORT****Resident Engineer:** Pursell, Gary**Address:** 333 Burma Road**City:** Oakland, CA 94607**Report No:** WIR-013145**Date Inspected:** 04-Apr-2010**Project Name:** SAS Superstructure**OSM Arrival Time:** 700**Prime Contractor:** American Bridge/Fluor Enterprises, a JV**OSM Departure Time:** 1900**Contractor:** Zhenhua Port Machinery Company, Ltd (ZPMC), Changxing Island **Location:** Shanghai, China**CWI Name:** Li Yang**CWI Present:** Yes No**Inspected CWI report:** Yes No N/A**Rod Oven in Use:** Yes No N/A**Electrode to specification:** Yes No N/A**Weld Procedures Followed:** Yes No N/A**Qualified Welders:** Yes No N/A**Verified Joint Fit-up:** Yes No N/A**Approved Drawings:** Yes No N/A**Approved WPS:** Yes No N/A**Delayed / Cancelled:** Yes No N/A**Bridge No:** 34-0006**Component:** OBG Segment**Summary of Items Observed:**

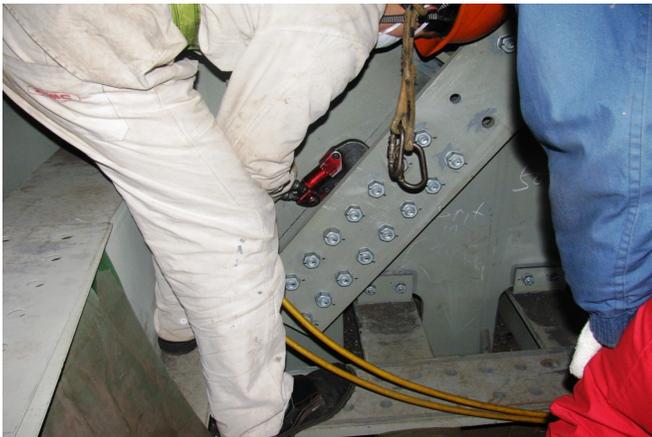
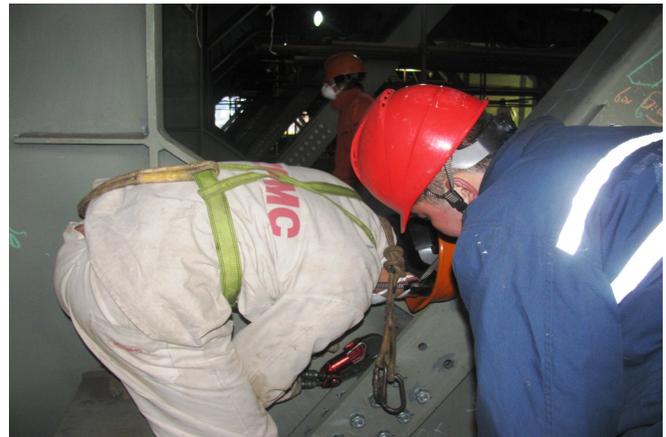
This QA inspector witnessed final tension verification for lower and upper chevron (North & South) of Segment 7AE and 7BE. Witnessed 10% on a random basis the bolts and found the tension to be in general compliance. The panel point and bolt size designations are as follows:

PP48 to PP 52:

M22 X 80 – DHGM 220050 – 486 NM

For further information, Please see the pictures below
