Contract #: 04-0120F4Cty: SF/ALA Rte: 80 PM: 13.2/13.9File #: 69.28**WELDING INSPECTION REPORT****Resident Engineer:** Pursell, Gary**Address:** 333 Burma Road**City:** Oakland, CA 94607**Report No:** WIR-013532**Date Inspected:** 13-Apr-2010**Project Name:** SAS Superstructure**OSM Arrival Time:** 700**Prime Contractor:** American Bridge/Fluor Enterprises, a JV**OSM Departure Time:** 1900**Contractor:** Zhenhua Port Machinery Company, Ltd (ZPMC), Changxing Island **Location:** Shanghai, China**CWI Name:** Gong Liang Zhu**CWI Present:** Yes No**Inspected CWI report:** Yes No N/A**Rod Oven in Use:** Yes No N/A**Electrode to specification:** Yes No N/A**Weld Procedures Followed:** Yes No N/A**Qualified Welders:** Yes No N/A**Verified Joint Fit-up:** Yes No N/A**Approved Drawings:** Yes No N/A**Approved WPS:** Yes No N/A**Delayed / Cancelled:** Yes No N/A**Bridge No:** 34-0006**Component:** Tower Components**Summary of Items Observed:**

## Tower Trial Assembly

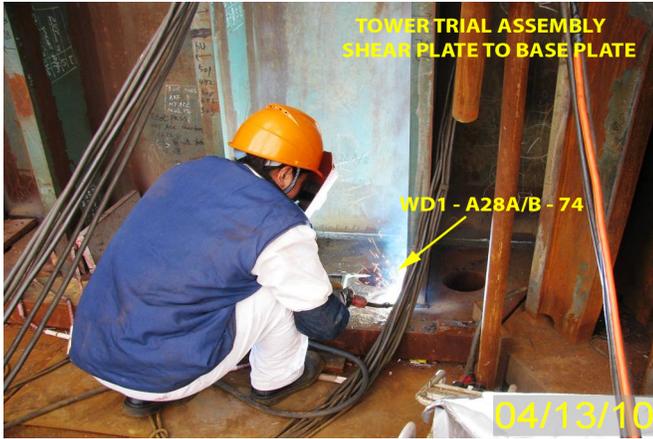
Weld joint # 074 located on base plate to shear plate WD1 – A28A/B between South and West shafts. Welder is identified as 054069. ZPMC Quality Control (QC) Inspector is identified as Fu Wei Min. The welding variables recorded by QC appeared to comply with the WPS – B – T – 2332 – Tc – P5 – F.

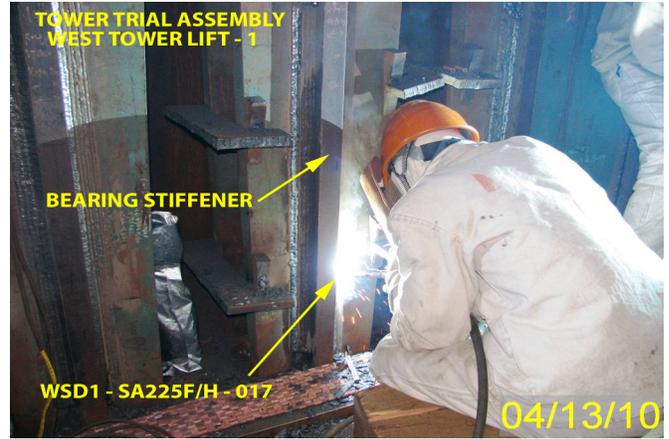
Weld joint # 017 located on West Tower Lift-1 Bearing stiffener WSD1 – SA225F/H. Welder is identified as 068865. ZPMC Quality Control (QC) Inspector is identified as Wang Chuangxin. The welding variables recorded by QC appeared to comply with the WPS – B – T – 2333 – Tc – P4 – F.
