Quality Assurance and Source Inspection

Contract #: 04-0120F4Cty: SF/ALA Rte: 80 PM: 13.2/13.9File #: 69.28**WELDING INSPECTION REPORT****Resident Engineer:** Pursell, Gary**Address:** 333 Burma Road**City:** Oakland, CA 94607**Report No:** WIR-013925**Date Inspected:** 09-May-2010**Project Name:** SAS Superstructure**OSM Arrival Time:** 1900**Prime Contractor:** American Bridge/Fluor Enterprises, a JV**OSM Departure Time:** 700**Contractor:** Zhenhua Port Machinery Company, Ltd (ZPMC), Changxing Island **Location:** Shanghai, China**CWI Name:** See Below**CWI Present:** Yes No**Inspected CWI report:** Yes No N/A**Rod Oven in Use:** Yes No N/A**Electrode to specification:** Yes No N/A**Weld Procedures Followed:** Yes No N/A**Qualified Welders:** Yes No N/A**Verified Joint Fit-up:** Yes No N/A**Approved Drawings:** Yes No N/A**Approved WPS:** Yes No N/A**Delayed / Cancelled:** Yes No N/A**Bridge No:** 34-0006**Component:** OBG**Summary of Items Observed:**

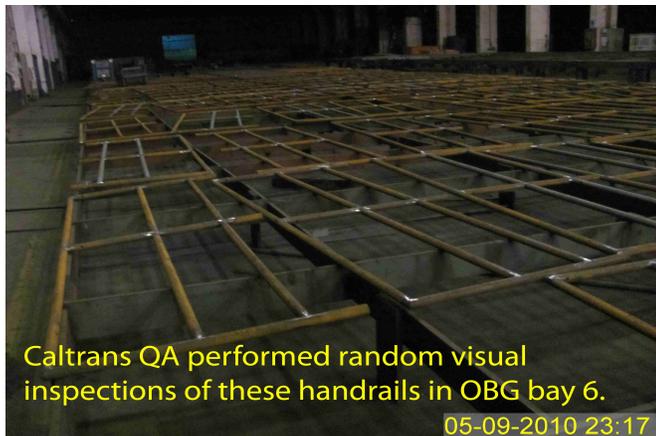
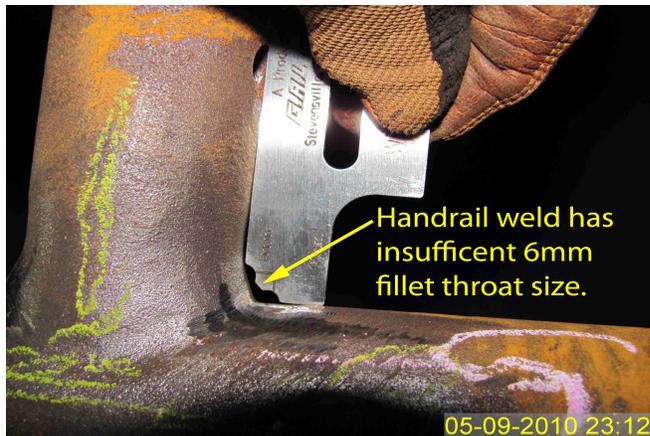
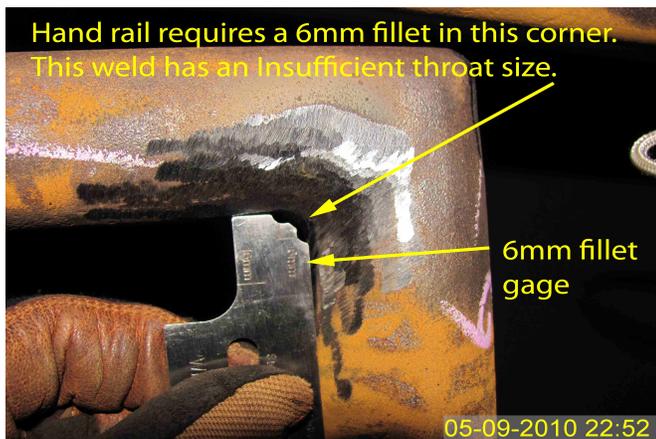
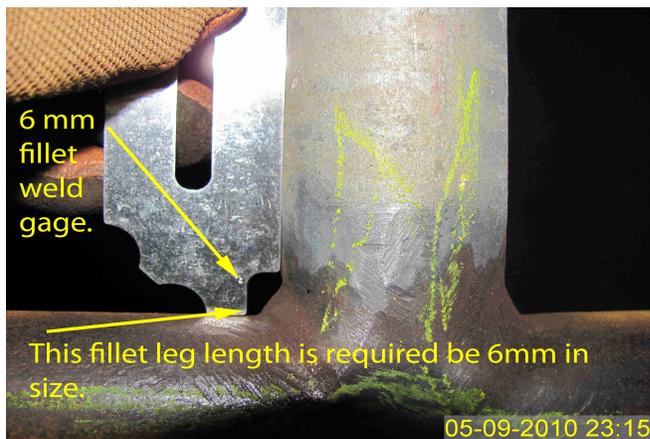
ZPMC QC provided Mr. Mike Hasler, B293 and Paul Dawson, B254 with a "Certificate of Conformance for Miscellaneous Member after Welding" form "C of C" which lists these welds. ZPMC also provided drawings that show that the hand rail structural members (pipes) are required be joined with 6mm fillet welds. All the handrail structural members (pipes) appear to be of the same diameter and it is not possible to make a fillet weld on the exterior of these weld joints where the surfaces that are being joined are flush, but the weld joints on the interior

corners of these handrails should all have minimum of a 6mm fillet. Mr. Hasler and this QA Inspector performed random visual inspection of approximately 15% of the hand rails and determined approximately 10% to 15% of the weld joints appear to have various amounts of insufficient fillet weld sizes. Some of the weld fillet joints have short leg lengths and some have insufficient throat size. The hand rails do appear to have metal tags that indicate the type (size) of each hand rail ie: RLZCA, RLZEA, RLZEB etc., but none of the hand rails have any other specific number to allow identification of any specific hand rail. Yellow markers were used to identify some of the areas where the fillet welds are undersize. See the photographs below for additional information. Items observed on this date do not fully appear to comply with applicable contract documents.
