**DEPARTMENT OF TRANSPORTATION**

Contract #: 04-0120F4Cty: SF/ALA Rte: 80 PM: 13.2/13.9File #: 69.28**WELDING INSPECTION REPORT****Resident Engineer:** Pursell, Gary**Address:** 333 Burma Road**City:** Oakland, CA 94607**Report No:** WIR-013929**Date Inspected:** 11-May-2010**Project Name:** SAS Superstructure**OSM Arrival Time:** 700**Prime Contractor:** American Bridge/Fluor Enterprises, a JV**OSM Departure Time:** 1900**Contractor:** Zhenhua Port Machinery Company, Ltd (ZPMC), Changxing Island **Location:** Shanghai, China**CWI Name:** Li Yang**CWI Present:** Yes No**Inspected CWI report:** Yes No N/A**Rod Oven in Use:** Yes No N/A**Electrode to specification:** Yes No N/A**Weld Procedures Followed:** Yes No N/A**Qualified Welders:** Yes No N/A**Verified Joint Fit-up:** Yes No N/A**Approved Drawings:** Yes No N/A**Approved WPS:** Yes No N/A**Delayed / Cancelled:** Yes No N/A**Bridge No:** 34-0006**Component:** OBG**Summary of Items Observed:**

On this day CALTRANS OSM Quality Assurance Inspector (QA) Joe Alaniz was present during the times noted above for observations relative to the fabrication of the SAS Superstructure being performed by Zhenhua Port Machinery Company (ZPMC)

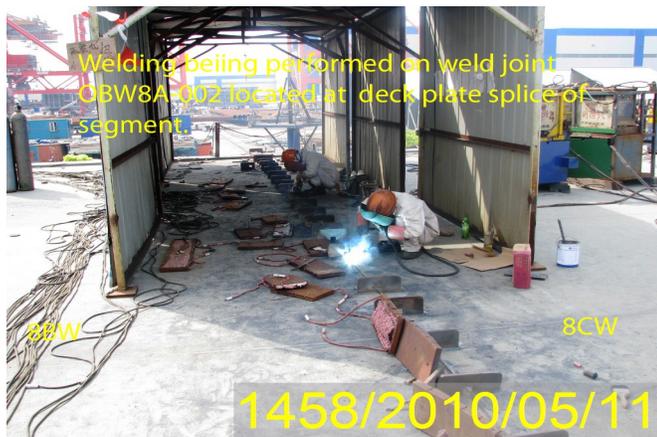
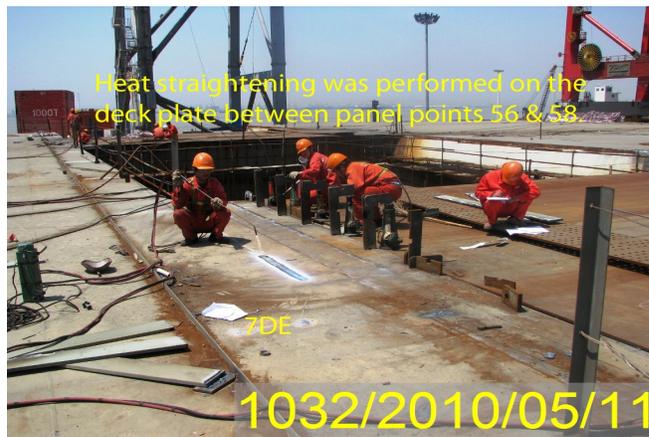
1. Heat straightening was performed on the deck plate to cross beam plate located between panel points 56 & 58 per HSR-364.
