DEPARTMENT OF TRANSPORTATION

Quality Assurance and Source Inspection

Contract #: 04-0120F4Cty: SF/ALA Rte: 80 PM: 13.2/13.9File #: 69.28**WELDING INSPECTION REPORT****Resident Engineer:** Pursell, Gary**Address:** 333 Burma Road**City:** Oakland, CA 94607**Report No:** WIR-014084**Date Inspected:** 02-May-2010**Project Name:** SAS Superstructure**OSM Arrival Time:** 700**Prime Contractor:** American Bridge/Fluor Enterprises, a JV**OSM Departure Time:** 1800**Contractor:** Zhenhua Port Machinery Company, Ltd (ZPMC), Changxing Island **Location:** Shanghai, China**CWI Name:** ZPMC and ABF**CWI Present:** Yes No**Inspected CWI report:** Yes No N/A**Rod Oven in Use:** Yes No N/A**Electrode to specification:** Yes No N/A**Weld Procedures Followed:** Yes No N/A**Qualified Welders:** Yes No N/A**Verified Joint Fit-up:** Yes No N/A**Approved Drawings:** Yes No N/A**Approved WPS:** Yes No N/A**Delayed / Cancelled:** Yes No N/A**Bridge No:** 34-0006**Component:** Tower**Summary of Items Observed:**

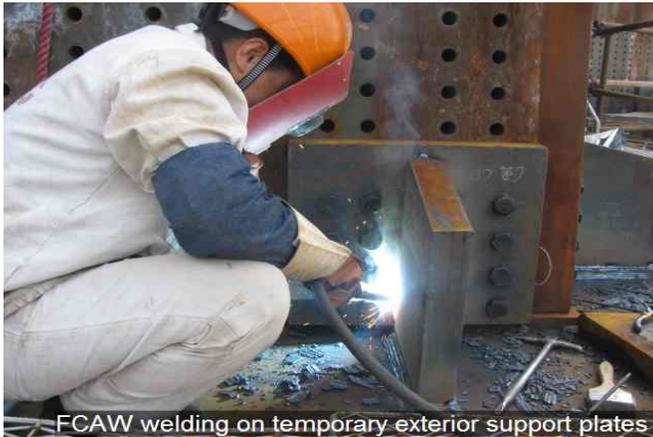
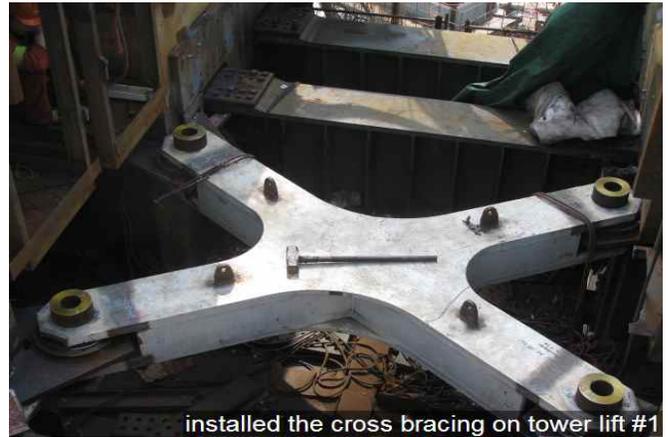
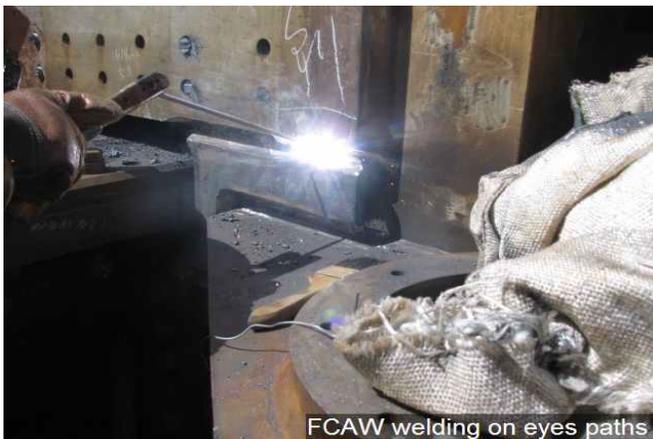
Caltrans QA Inspector observed four ZPMC welders in process FCAW process on temporary exterior support plates for skin A/B/C/D of all tower lift #2. The material used for temporary exterior support plates were reported by ZPMC QC as ASTM a 709M-345 plate with 20mm wall thickness. The weld is designed PJP weld with welded in 3G position. The FCAW process was monitored and recorded by ZPMC and ABF QC inspector. Based on Caltrans QAI observations, no discrepancies were noted.

Caltrans QA inspector observed fifteen ZPMC workers installed the cross bracing on tower lift #1. The cross bracing is located at elevation 47.6M of East/West/South/North tower #lift 1. The four eyes holes of cross bracing have been marked for holes drilling after secured by the pins. The cross bracing has been removed to ground floor after the survey completed by ZPMC. The four eyes holes will be start holes drilling tomorrow.

Caltrans QA Inspector observed four ZPMC welders in process FCAW process on four eye paths. The eye paths are located at elevation 47.6M of East/West/South/North tower #lift 1 and use for hold cross bracing. The weld is designed CJP weld with welded in 3G position. The FCAW process was monitored and recorded by ZPMC and ABF QC inspector. Based on Caltrans QAI observations, no discrepancies were noted.
