**DEPARTMENT OF TRANSPORTATION**

Contract #: 04-0120F4Cty: SF/ALA Rte: 80 PM: 13.2/13.9File #: 69.28**WELDING INSPECTION REPORT****Resident Engineer:** Pursell, Gary**Address:** 333 Burma Road**City:** Oakland, CA 94607**Report No:** WIR-014370**Date Inspected:** 23-May-2010**Project Name:** SAS Superstructure**OSM Arrival Time:** 700**Prime Contractor:** American Bridge/Fluor Enterprises, a JV**OSM Departure Time:** 1500**Contractor:** Zhenhua Port Machinery Company, Ltd (ZPMC), Changxing Island **Location:** Shanghai, China**CWI Name:** Li Yang**CWI Present:** Yes No**Inspected CWI report:** Yes No N/A**Rod Oven in Use:** Yes No N/A**Electrode to specification:** Yes No N/A**Weld Procedures Followed:** Yes No N/A**Qualified Welders:** Yes No N/A**Verified Joint Fit-up:** Yes No N/A**Approved Drawings:** Yes No N/A**Approved WPS:** Yes No N/A**Delayed / Cancelled:** Yes No N/A**Bridge No:** 34-0006**Component:** OBG**Summary of Items Observed:**

## WELDING INSPECTION REPORT

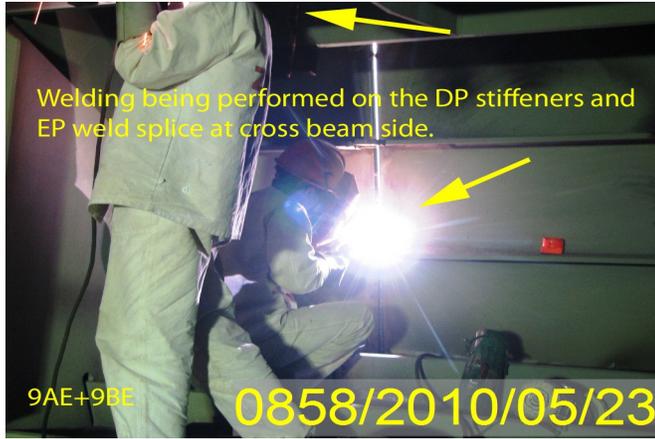
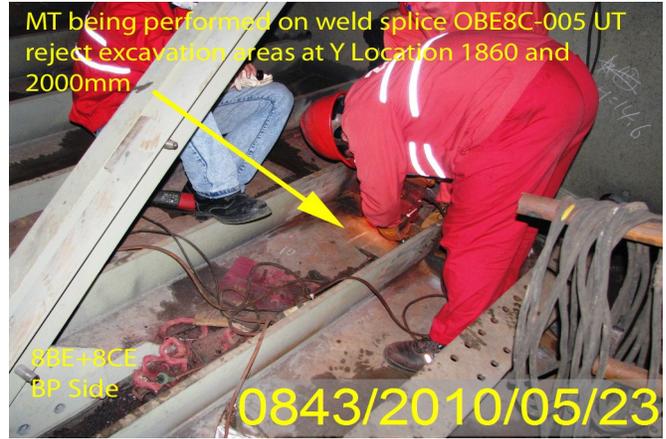
Flux Core Arc Welding (FCAW) welding was performed on weld joint 002 located at OBE9 deck plate weld splice cross beam side of segment. Welder is identified as Mr. Zhang Hanming (220066). ZPMC QC is identified as Liu Huajie. The welding variables monitored and recorded by the QC appeared to comply with WPS-B-T-223(2)1T-1.

1. Side plate weld splice OBE8C-005 UT reject excavation areas at Y Location 1860 and 2000mm on the bike path side of segment, per CWR 1525.
