DEPARTMENT OF TRANSPORTATION

Quality Assurance and Source Inspection

Contract #: 04-0120F4Cty: SF/ALA Rte: 80 PM: 13.2/13.9File #: 69.28**WELDING INSPECTION REPORT****Resident Engineer:** Pursell, Gary**Address:** 333 Burma Road**City:** Oakland, CA 94607**Report No:** WIR-014978**Date Inspected:** 12-Jun-2010**Project Name:** SAS Superstructure**OSM Arrival Time:** 700**Prime Contractor:** American Bridge/Fluor Enterprises, a JV**OSM Departure Time:** 1900**Contractor:** Zhenhua Port Machinery Company, Ltd (ZPMC), Changxing Island **Location:** Shanghai, China**CWI Name:** Wu Zhi Chang**CWI Present:** Yes No**Inspected CWI report:** Yes No N/A**Rod Oven in Use:** Yes No N/A**Electrode to specification:** Yes No N/A**Weld Procedures Followed:** Yes No N/A**Qualified Welders:** Yes No N/A**Verified Joint Fit-up:** Yes No N/A**Approved Drawings:** Yes No N/A**Approved WPS:** Yes No N/A**Delayed / Cancelled:** Yes No N/A**Bridge No:** 34-0006**Component:** Orthotropic Box Girder (OBG)**Summary of Items Observed:**

Segment 8BE to 8CE (T-Ribs after Bolting) Caltrans QA Survey Inspection

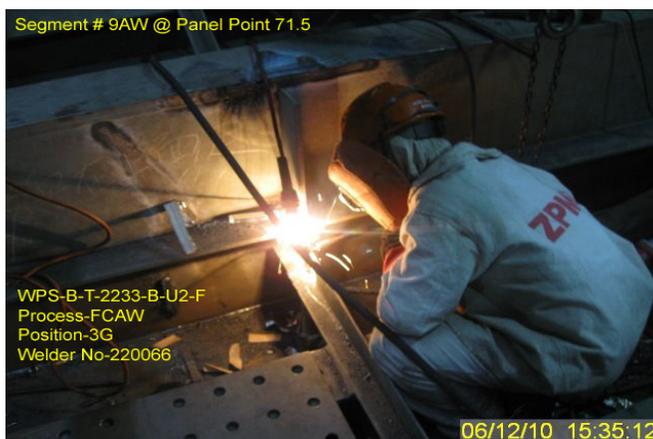
This QA inspector observed ZPMC qualified welding personnel identified as 220066 perform Flux Core Arc Welding (FCAW), weld joint identified as SSD029-PP71.5-251 and was observed welding in the 3G (Vertical) position; ZPMC QC is identified as Mr. Wang Zhu. The welding parameters measured using QC's calibrated instrument appeared to be in general compliance with WPS-B-T-2233-B-U2-F. See the attached below Photo.

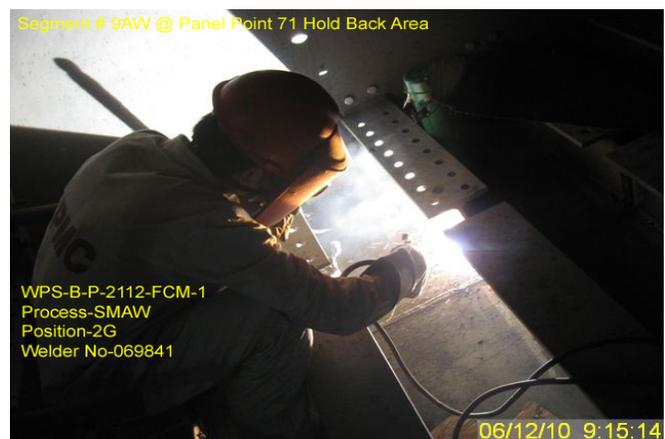
This QA inspector observed ZPMC qualified welding personnel identified as 069841 perform Shielded Metal Arc Welding (SMAW), weld joint identified as SS159-001-032 and was observed welding in the 2G (Horizontal) position; ZPMC QC is identified as Mr. Wang Zhu. The welding parameters measured using QC's calibrated instrument appeared to be in general compliance with WPS-B-P-2112-FCM-1. See the attached below Photo.
