Contract #: 04-0120F4Cty: SF/ALA Rte: 80 PM: 13.2/13.9File #: 69.28**WELDING INSPECTION REPORT****Resident Engineer:** Pursell, Gary**Address:** 333 Burma Road**City:** Oakland, CA 94607**Report No:** WIR-015038**Date Inspected:** 22-Jun-2010**Project Name:** SAS Superstructure**OSM Arrival Time:** 700**Prime Contractor:** American Bridge/Fluor Enterprises, a JV**OSM Departure Time:** 1900**Contractor:** Zhenhua Port Machinery Company, Ltd (ZPMC), Changxing Island **Location:** Shanghai, China**CWI Name:** Li Yang**CWI Present:** Yes No**Inspected CWI report:** Yes No N/A**Rod Oven in Use:** Yes No N/A**Electrode to specification:** Yes No N/A**Weld Procedures Followed:** Yes No N/A**Qualified Welders:** Yes No N/A**Verified Joint Fit-up:** Yes No N/A**Approved Drawings:** Yes No N/A**Approved WPS:** Yes No N/A**Delayed / Cancelled:** Yes No N/A**Bridge No:** 34-0006**Component:** OBG Segment**Summary of Items Observed:**

WELDING INSPECTION REPORT

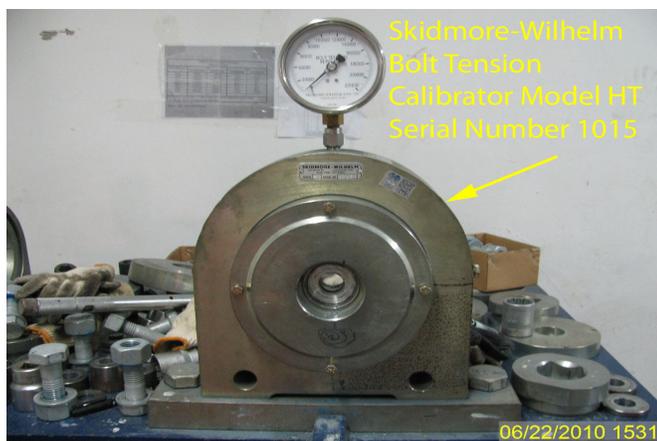
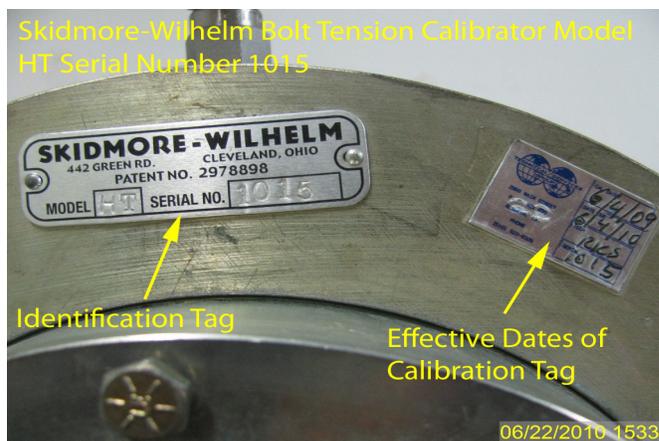
During the Quality Assurance Pre-Installation Verification of Required Tension for M24x70 high strength bolts, this QA Inspector discovered the following issues:

- The Skidmore-Wilhelm Bolt Tension Calibrator Model HT Serial Number 1015 calibration date had expired.
- Valid Dates of calibration are from 06/04/2009 thru 06/04/2010.
- Calibration dates are displayed on the Bolt Tension Calibrator.

An Incident Report was written for this issue.
