DEPARTMENT OF TRANSPORTATION

Contract #: 04-0120F4Cty: SF/ALA Rte: 80 PM: 13.2/13.9File #: 69.28**WELDING INSPECTION REPORT****Resident Engineer:** Pursell, Gary**Address:** 333 Burma Road**City:** Oakland, CA 94607**Report No:** WIR-015085**Date Inspected:** 21-Jun-2010**Project Name:** SAS Superstructure**OSM Arrival Time:** 700**Prime Contractor:** American Bridge/Fluor Enterprises, a JV**OSM Departure Time:** 1900**Contractor:** Zhenhua Port Machinery Company, Ltd (ZPMC), Changxing Island **Location:** Shanghai, China**CWI Name:** Chen Shi Gang**CWI Present:** Yes No**Inspected CWI report:** Yes No N/A**Rod Oven in Use:** Yes No N/A**Electrode to specification:** Yes No N/A**Weld Procedures Followed:** Yes No N/A**Qualified Welders:** Yes No N/A**Verified Joint Fit-up:** Yes No N/A**Approved Drawings:** Yes No N/A**Approved WPS:** Yes No N/A**Delayed / Cancelled:** Yes No N/A**Bridge No:** 34-0006**Component:** OBG**Summary of Items Observed:**

OBG Bay 04, Deck Panel 13BE-DP3088-001

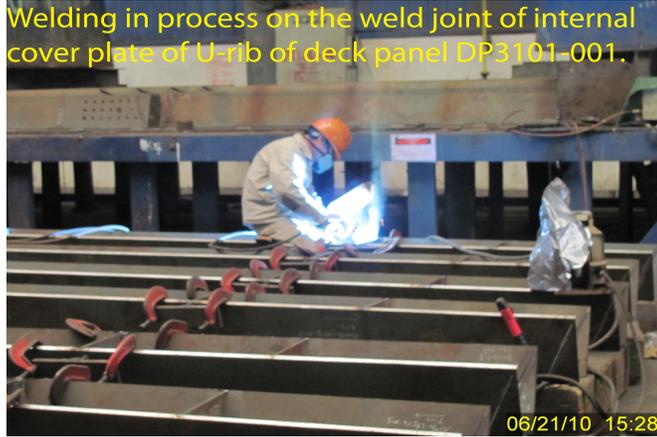
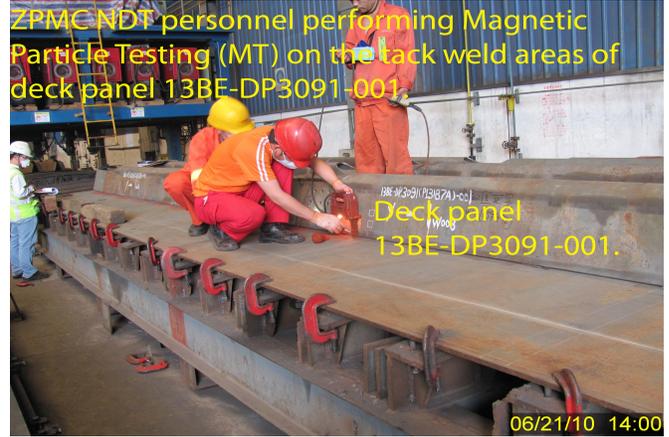
This QA inspector performed conventional Ultrasonic Testing (UT) Inspection on deck panel tack weld areas. The inspection is preliminary prior to using the phased array (PAUT) testing system to verify indications found with conventional Ultrasonic testing. QA inspector performed UT on deck panel 13BE-DP3088-001, 10 ribs, 20 welds, 180 total tack welds inspected.

BAY 09, U-rib Internal Cover Plate

FCAW welding of weld joint 216 located on DP3104-001.
