DEPARTMENT OF TRANSPORTATION

Contract #: 04-0120F4Cty: SF/ALA Rte: 80 PM: 13.2/13.9File #: 69.28**WELDING INSPECTION REPORT****Resident Engineer:** Pursell, Gary**Address:** 333 Burma Road**City:** Oakland, CA 94607**Report No:** WIR-015206**Date Inspected:** 17-Jun-2010**Project Name:** SAS Superstructure**OSM Arrival Time:** 700**Prime Contractor:** American Bridge/Fluor Enterprises, a JV**OSM Departure Time:** 1900**Contractor:** Zhenhua Port Machinery Company, Ltd (ZPMC), Changxing Island **Location:** Shanghai, China

TOWER JETTY

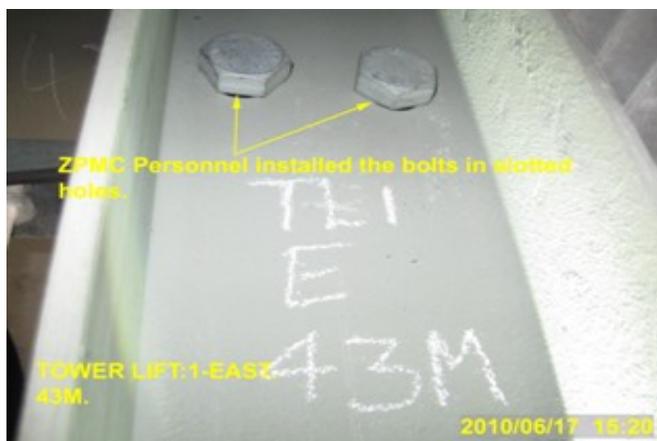
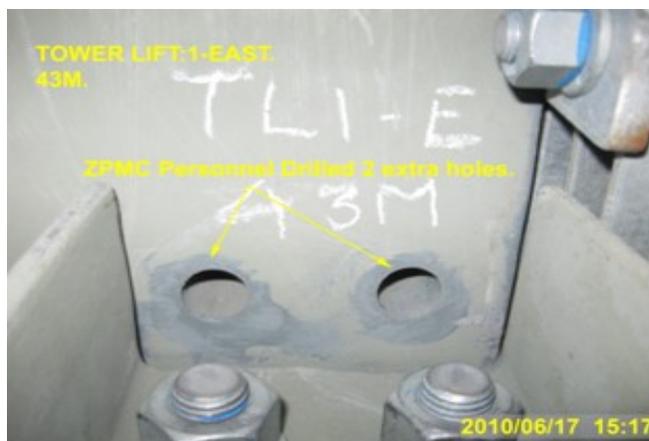
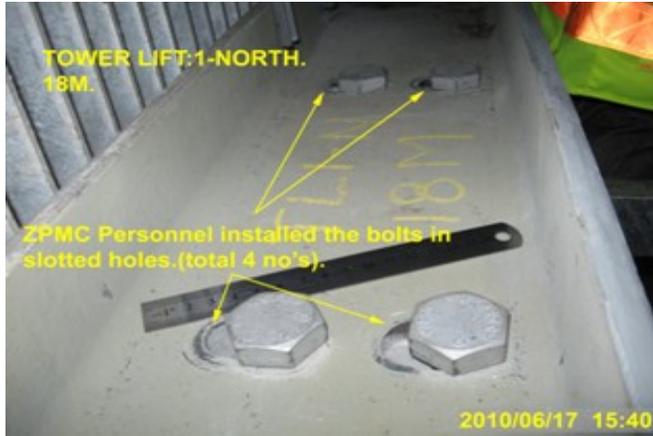
(QA) Inspector observed Two (2) additional bolt holes at 43m in East Tower. These additional holes are deviation from the approved contract drawings. ZPMC personnel installed two (2) bolts into slotted/elongated holes in East Tower at 43m for ladder supports. ZPMC personnel installed four (4) bolts into slotted/elongated holes in North Tower at 18m for ladder supports.

This QA Inspector generated an incident report for the above issue, for further information see the incident report and attached photos.
