**DEPARTMENT OF TRANSPORTATION**

Contract #: 04-0120F4Cty: SF/ALA Rte: 80 PM: 13.2/13.9File #: 69.28**WELDING INSPECTION REPORT****Resident Engineer:** Pursell, Gary**Address:** 333 Burma Road**City:** Oakland, CA 94607**Report No:** WIR-015304**Date Inspected:** 23-Jun-2010**Project Name:** SAS Superstructure**OSM Arrival Time:** 700**Prime Contractor:** American Bridge/Fluor Enterprises, a JV**OSM Departure Time:** 1900**Contractor:** Zhenhua Port Machinery Company, Ltd (ZPMC), Changxing Island **Location:** Shanghai, China

## WELDING INSPECTION REPORT

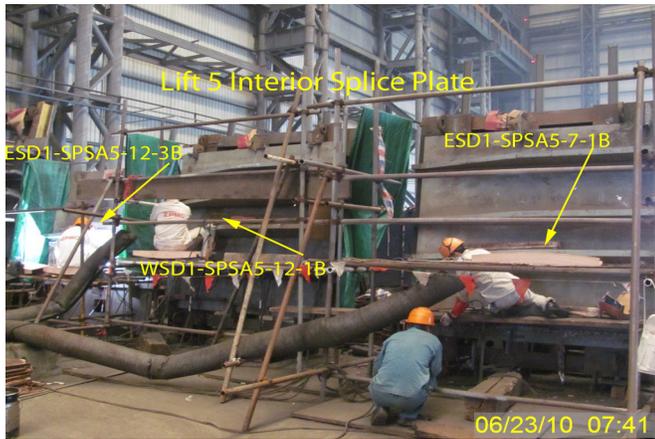
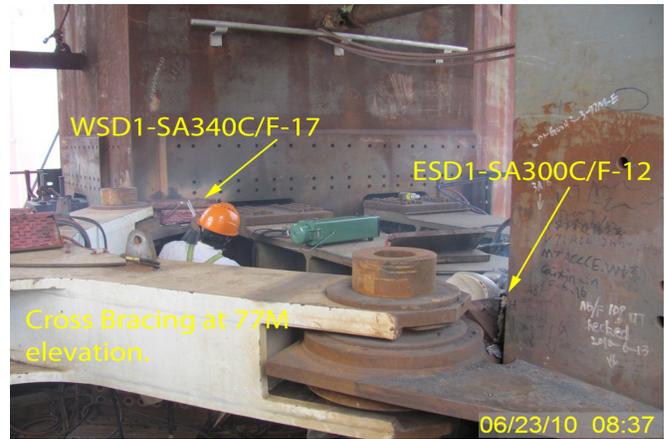
SMAW welding of weld joint no: NSD1-SA166C/F-18 located on Doubler strut plate at 77M elevation. Welder is identified as 040365. ZPMC CWI is identified as Mr. Qiu wen. The welding variables recorded by QC appeared to comply with the WPS-B-T-4212-TC-U4c-4. Please see the attached picture.

SMAW welding of weld joint no: WSD1-SA340C/F-17 located on Doubler strut plate at 77M elevation. Welder is identified as 040690. ZPMC CWI is identified as Mr. Qiu wen. The welding variables recorded by QC appeared to comply with the WPS-B-T-4212-TC-U4c-4. Please see the attached picture.

SMAW welding of weld joint no: ESD1-SPSA5-7-1B located on Lift 5 Interior Splice Plate. Welder is identified as 046709. ZPMC QC is identified as Mr. Xu jie. The welding variables recorded by QC appeared to comply with the WPS-B-T-3211-TC-U5b-1. Please see the attached picture.

SMAW welding of weld joint no: WSD1-SPSA5-12-1B located on Lift 5 Interior Splice Plate. Welder is identified as 046704. ZPMC QC is identified as Mr. Xu jie. The welding variables recorded by QC appeared to comply with the WPS-B-T-3211-TC-U5b-1. Please see the attached picture
