DEPARTMENT OF TRANSPORTATION

Contract #: 04-0120F4Cty: SF/ALA Rte: 80 PM: 13.2/13.9File #: 69.28**WELDING INSPECTION REPORT****Resident Engineer:** Pursell, Gary**Address:** 333 Burma Road**City:** Oakland, CA 94607**Report No:** WIR-015367**Date Inspected:** 05-Jul-2010**Project Name:** SAS Superstructure**OSM Arrival Time:** 700**Prime Contractor:** American Bridge/Fluor Enterprises, a JV**OSM Departure Time:** 1900**Contractor:** Zhenhua Port Machinery Company, Ltd (ZPMC), Changxing Island **Location:** Shanghai, China

CWI Name:	Li Yang and Wu Zhi Cheng	CWI Present:	Yes	No
Inspected CWI report:	Yes No N/A	Rod Oven in Use:	Yes	No N/A
Electrode to specification:	Yes No N/A	Weld Procedures Followed:	Yes	No N/A
Qualified Welders:	Yes No N/A	Verified Joint Fit-up:	Yes	No N/A
Approved Drawings:	Yes No N/A	Approved WPS:	Yes	No N/A
		Delayed / Cancelled:	Yes	No N/A
Bridge No:	34-0006	Component:	OBG Trial Assembly

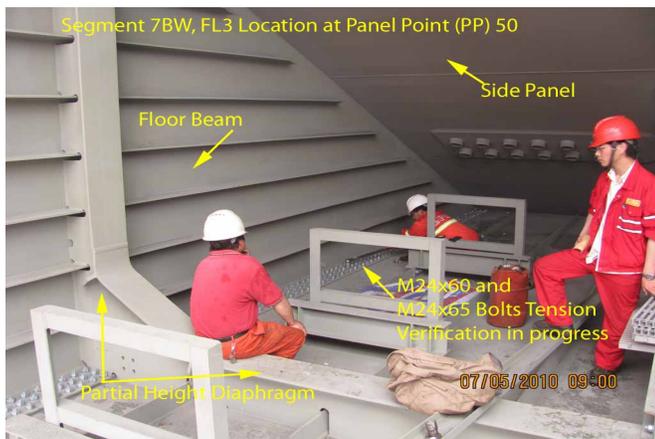
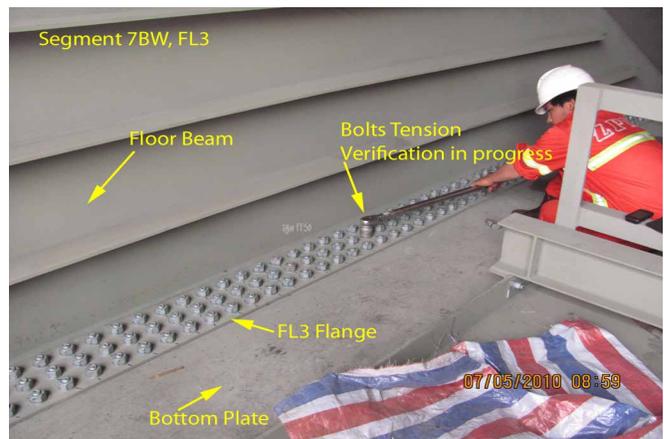
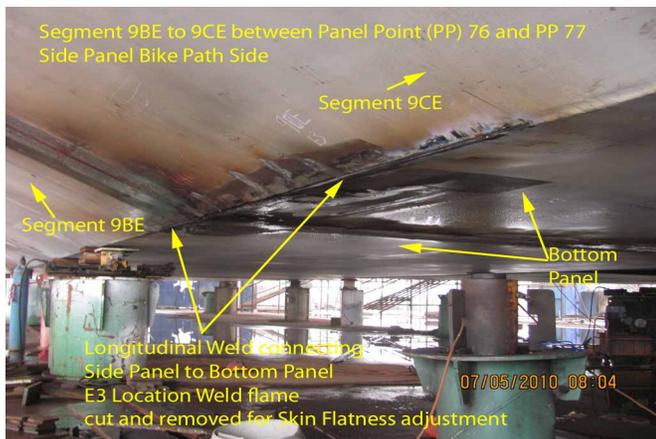
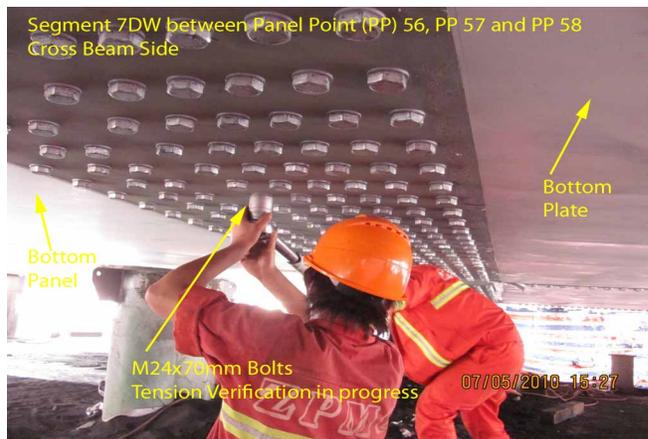
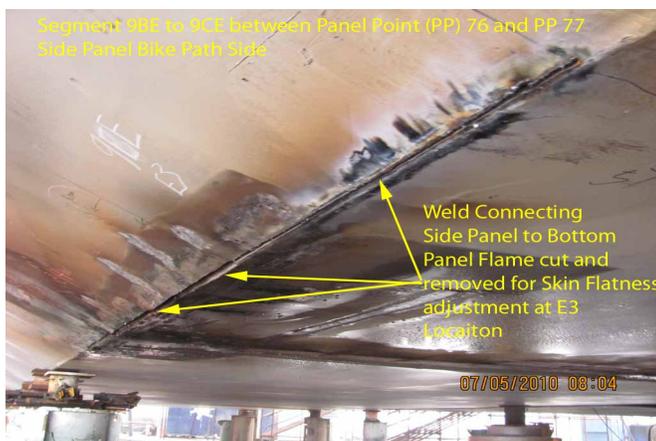
This Quality Assurance Inspector (QAI) witnessed the final bolt tension verification on bolts connecting the FL3 Flange to the Bottom Plate and the Bottom Plate to Bottom Panel between Panel Points (PP) 50, PP 51 and PP 52 for Segment 7BW. The QAI verified the bolt tension on a random basis and the results appeared to be in general compliance. The Inspection was performed against Notification No. 00410 dated July 05, 2010.

The manual torque wrench used to verify tension was S/N XQ2-109. Please reference the pictures attached for more comprehensive details.

This Quality Assurance Inspector (QAI) witnessed the final bolt tension verification on bolts connecting the FL3 Flange to the Bottom Plate and the Bottom Plate to Bottom Panel between Panel Points (PP) 56, PP 57 and PP 58 for Segment 7DW. The QAI verified the bolt tension on a random basis and the results appeared to be in general compliance. The Inspection was performed against Notification No. 00410 dated July 05, 2010.

This QA Inspector observed the in-process welding by Flux Cored Arc Welding (FCAW) process on the buttering of the web on the Longitudinal Diaphragm (LD) at Work Point E3. The LD was identified as LD12B. The welder identification was 062092 and was observed welding in the 1G (Flat) position using approved Welding Procedure Specification WPS-B-T-2231T-1. The buttering operation was performed on LD to LD on Segment 9BE to Segment 9CE. The vertical offset measured was 20mm.

Note: The weld connecting the Side Panel to Bottom Panel at Work Point E3 (Longitudinal weld) was flame cut to adjust the skin flatness. Please reference the pictures attached for more comprehensive details.
