**DEPARTMENT OF TRANSPORTATION**

Contract #: 04-0120F4Cty: SF/ALA Rte: 80 PM: 13.2/13.9File #: 69.28**WELDING INSPECTION REPORT****Resident Engineer:** Pursell, Gary**Address:** 333 Burma Road**City:** Oakland, CA 94607**Report No:** WIR-015482**Date Inspected:** 07-Jul-2010**Project Name:** SAS Superstructure**OSM Arrival Time:** 1900**Prime Contractor:** American Bridge/Fluor Enterprises, a JV**OSM Departure Time:** 700**Contractor:** Zhenhua Port Machinery Company, Ltd (ZPMC), Changxing Island **Location:** Shanghai, China**CWI Name:** See Below**CWI Present:** Yes No**Inspected CWI report:** Yes No N/A**Rod Oven in Use:** Yes No N/A**Electrode to specification:** Yes No N/A**Weld Procedures Followed:** Yes No N/A**Qualified Welders:** Yes No N/A**Verified Joint Fit-up:** Yes No N/A**Approved Drawings:** Yes No N/A**Approved WPS:** Yes No N/A**Delayed / Cancelled:** Yes No N/A**Bridge No:** 34-0006**Component:** OBG**Summary of Items Observed:**

## WELDING INSPECTION REPORT

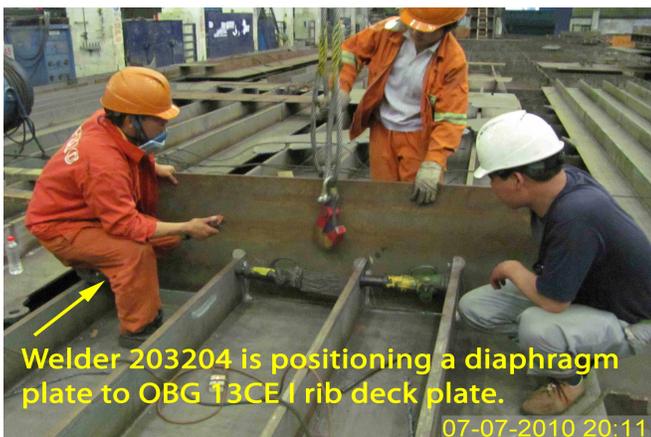
This QA Inspector observed ZPMC welder Mr. Xiao Di, stencil 203204 was using shielded metal arc procedure WPS-T-T-4112-4 to tack weld OBG segment 13CE deck plate DP3108-001-167. This 2F position weld joins a diaphragm plate to the deck plate. This QA Inspector observed a welding current of approximately 180 amps and Mr. Xiao Di appears to be certified to make this weld. This QA Inspector observed ZPMC preheated the base material prior to welding. Items observed by the QA Inspector appear to comply with project specifications. See the photograph below for additional information.
