DEPARTMENT OF TRANSPORTATION

Contract #: 04-0120F4Cty: SF/ALA Rte: 80 PM: 13.2/13.9File #: 69.28**WELDING INSPECTION REPORT****Resident Engineer:** Pursell, Gary**Address:** 333 Burma Road**City:** Oakland, CA 94607**Report No:** WIR-015555**Date Inspected:** 12-Jul-2010**Project Name:** SAS Superstructure**OSM Arrival Time:** 700**Prime Contractor:** American Bridge/Fluor Enterprises, a JV**OSM Departure Time:** 1900**Contractor:** Zhenhua Port Machinery Company, Ltd (ZPMC), Changxing Island **Location:** Shanghai, China**CWI Name:** Li Yang**CWI Present:** Yes No**Inspected CWI report:** Yes No N/A**Rod Oven in Use:** Yes No N/A**Electrode to specification:** Yes No N/A**Weld Procedures Followed:** Yes No N/A**Qualified Welders:** Yes No N/A**Verified Joint Fit-up:** Yes No N/A**Approved Drawings:** Yes No N/A**Approved WPS:** Yes No N/A**Delayed / Cancelled:** Yes No N/A**Bridge No:** 34-0006**Component:** OBG Segment**Summary of Items Observed:**

OBG # TRIAL ASSEMBLY YARD (CB9)

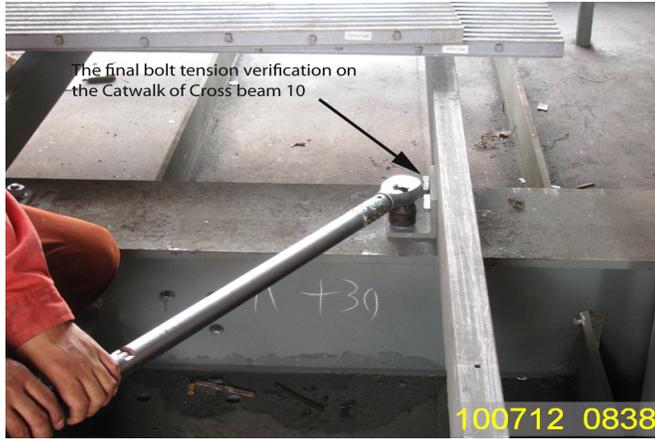
This QA Inspector witnessed the final bolt tension verification on the Catwalk of Cross beam 9. The torque wrench S/N was X02-776. The QA Inspector witnessed 10% of the bolts on a random basis and found the tensioning of the bolts appeared to be in general compliance. The bolt size designations were as follows:

For additional information please reference the pictures below:
