**DEPARTMENT OF TRANSPORTATION**

Contract #: 04-0120F4Cty: SF/ALA Rte: 80 PM: 13.2/13.9File #: 69.28**WELDING INSPECTION REPORT****Resident Engineer:** Pursell, Gary**Address:** 333 Burma Road**City:** Oakland, CA 94607**Report No:** WIR-015571**Date Inspected:** 12-Jul-2010**Project Name:** SAS Superstructure**OSM Arrival Time:** 700**Prime Contractor:** American Bridge/Fluor Enterprises, a JV**OSM Departure Time:** 1900**Contractor:** Zhenhua Port Machinery Company, Ltd (ZPMC), Changxing Island **Location:** Shanghai, China**CWI Name:** Mr. Huang min**CWI Present:** Yes No**Inspected CWI report:** Yes No N/A**Rod Oven in Use:** Yes No N/A**Electrode to specification:** Yes No N/A**Weld Procedures Followed:** Yes No N/A**Qualified Welders:** Yes No N/A**Verified Joint Fit-up:** Yes No N/A**Approved Drawings:** Yes No N/A**Approved WPS:** Yes No N/A**Delayed / Cancelled:** Yes No N/A**Bridge No:** 34-0006**Component:** Orthotropic Box Girder (OBG)**Summary of Items Observed:**

# WELDING INSPECTION REPORT

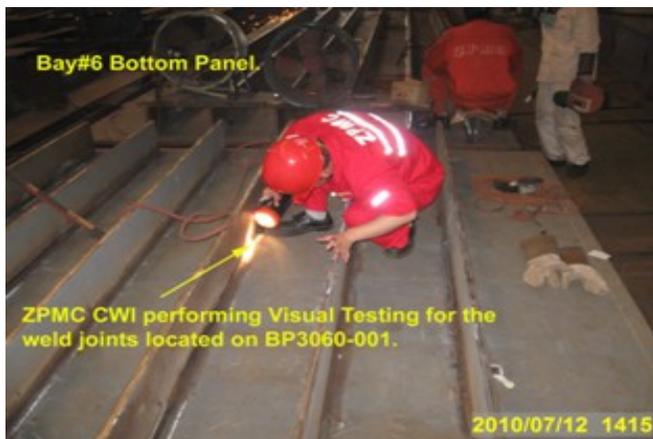
ZPMC QC Certified Welding Inspector Mr. Huang min was performing Visual Testing for the welds located on Bottom Panel identified as BP3060-001. Refer attached photos for additional details.
