**DEPARTMENT OF TRANSPORTATION**

Quality Assurance and Source Inspection

Contract #: 04-0120F4Cty: SF/ALA Rte: 80 PM: 13.2/13.9File #: 69.28**WELDING INSPECTION REPORT****Resident Engineer:** Pursell, Gary**Address:** 333 Burma Road**City:** Oakland, CA 94607**Report No:** WIR-015660**Date Inspected:** 14-Jul-2010**Project Name:** SAS Superstructure**OSM Arrival Time:** 700**Prime Contractor:** American Bridge/Fluor Enterprises, a JV**OSM Departure Time:** 1900**Contractor:** Zhenhua Port Machinery Company, Ltd (ZPMC), Changxing Island **Location:** Shanghai, China**CWI Name:** Yang Bai Qiang**CWI Present:** Yes No**Inspected CWI report:** Yes No N/A**Rod Oven in Use:** Yes No N/A**Electrode to specification:** Yes No N/A**Weld Procedures Followed:** Yes No N/A**Qualified Welders:** Yes No N/A**Verified Joint Fit-up:** Yes No N/A**Approved Drawings:** Yes No N/A**Approved WPS:** Yes No N/A**Delayed / Cancelled:** Yes No N/A**Bridge No:** 34-0006**Component:** OBG**Summary of Items Observed:**

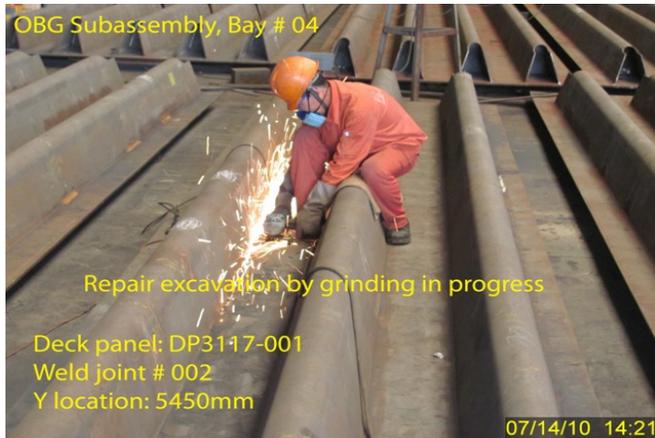
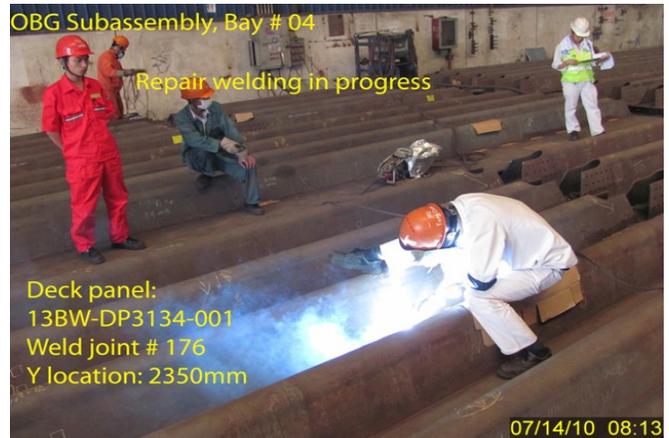
During random in process inspection this QA inspector observed that ZPMC personnel were performing repair excavation by grinding on PAUT repair locations. ZPMC QC is identified as Mr. Zhang Hai Tao. The repair excavation details are as follows

During random in process inspection this QA inspector observed that ZPMC personnel were performing repair welding on the Partial Joint Penetration (PJP) weld joints of deck panel 13BW-DP3134-001. Welder is identified as 203805. ZPMC CWI is identified as Mr. Yang Bai Qiang. The welding variables recorded by QC appeared to comply with WPS-345-FCAW-2G(2F)-FCM-Repair. The repair area details are as follows.
