**DEPARTMENT OF TRANSPORTATION**

Contract #: 04-0120F4Cty: SF/ALA Rte: 80 PM: 13.2/13.9File #: 69.28**WELDING INSPECTION REPORT****Resident Engineer:** Pursell, Gary**Address:** 333 Burma Road**City:** Oakland, CA 94607**Report No:** WIR-015734**Date Inspected:** 15-Jul-2010**Project Name:** SAS Superstructure**OSM Arrival Time:** 700**Prime Contractor:** American Bridge/Fluor Enterprises, a JV**OSM Departure Time:** 1900**Contractor:** Zhenhua Port Machinery Company, Ltd (ZPMC), Changxing Island **Location:** Shanghai, China

**TOWER JETTY****MEASUREMENTS ON VERTICAL TRIAL ASSEMBLY NORTH TOWER LIFT-2&3**

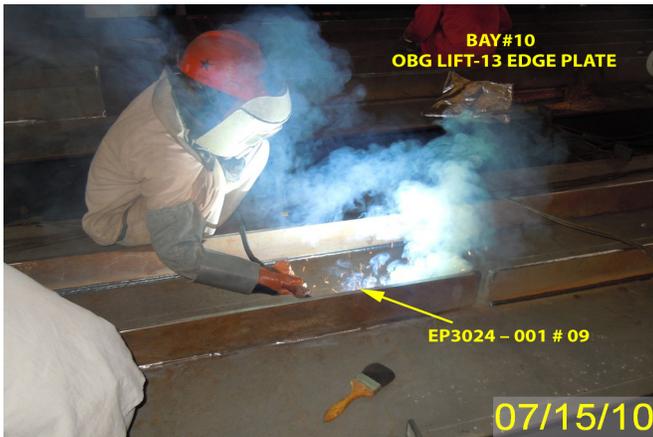
Weld joint # 9A located on North tower Lift-5 Grillage Assembly NSD1 – TL5 – 3E/F. Welder is identified as 052930. ZPMC Quality Control (QC) Inspector is identified as Li Peng Fei. The welding variables recorded by QC appeared to comply with the WPS – B – T – 3213 – TC – U5b. (See attached photo)

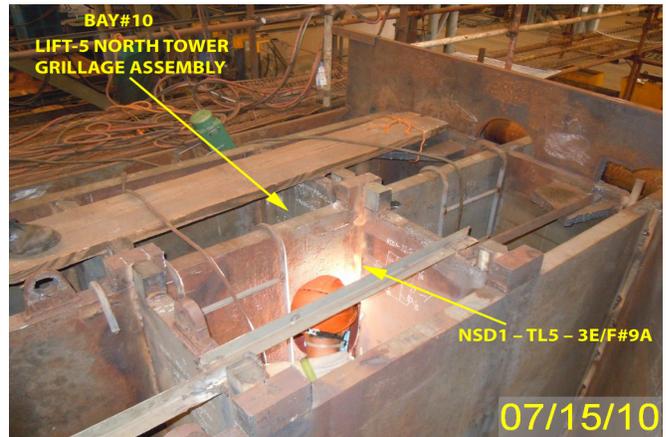
Weld joint # 09 located on Edge Plate EP3024 – 001. Welder is identified as 052075. ZPMC Quality Control (QC) Inspector is identified as Lu Wei Chao. The welding variables recorded by QC appeared to comply with the WPS – B – T – 2132. (See attached photo)

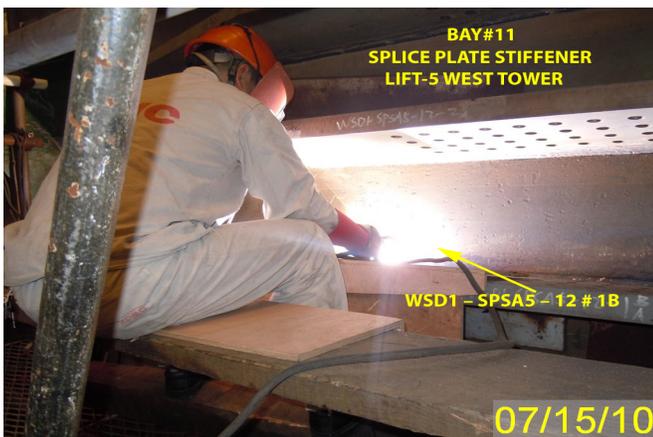
Weld joint # 1B located on Lift-5 Splice Plate Stiffener WSD1 – SPSA5 – 12. Welder is identified as 046704. ZPMC Quality Control (QC) Inspector is identified as Liu Dao Feng. The welding variables recorded by QC appeared to comply with the WPS – B – T – 3211 – Tc – U5b – 1. (See attached photo)
