Quality Assurance and Source Inspection

Contract #: 04-0120F4Cty: SF/Ala Rte: 80 PM: 13.2/13.9File #: 69.28**WELDING INSPECTION REPORT****Resident Engineer:** Pursell, Gary**Address:** 333 Burma Road**City:** Oakland, CA 94607**Report No:** WIR-015749**Date Inspected:** 14-Jul-2010**Project Name:** SAS Superstructure**OSM Arrival Time:** 1900**Prime Contractor:** American Bridge/Fluor Enterprises, a JV**OSM Departure Time:** 700**Contractor:** Zhenhua Port Machinery Company, Ltd (ZPMC), Changxing Island **Location:** Shanghai, China**CWI Name:** See below**CWI Present:** Yes No**Inspected CWI report:** Yes No N/A**Rod Oven in Use:** Yes No N/A**Electrode to specification:** Yes No N/A**Weld Procedures Followed:** Yes No N/A**Qualified Welders:** Yes No N/A**Verified Joint Fit-up:** Yes No N/A**Approved Drawings:** Yes No N/A**Approved WPS:** Yes No N/A**Delayed / Cancelled:** Yes No N/A**Bridge No:** 34-0006**Component:** Tower and OBG Components**Summary of Items Observed:**

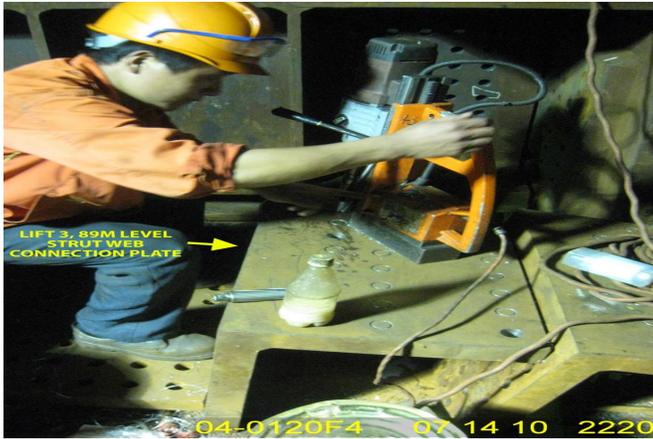
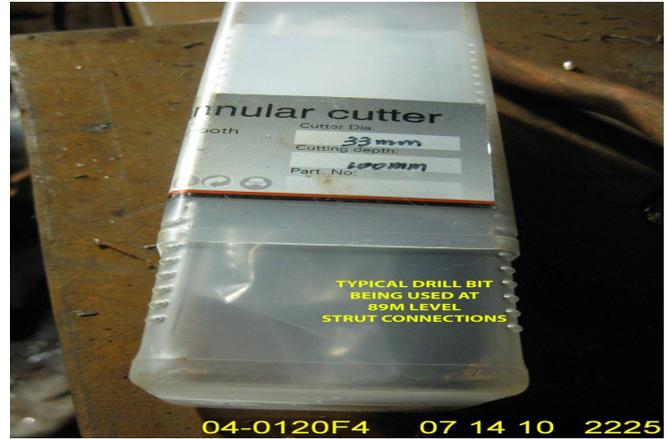
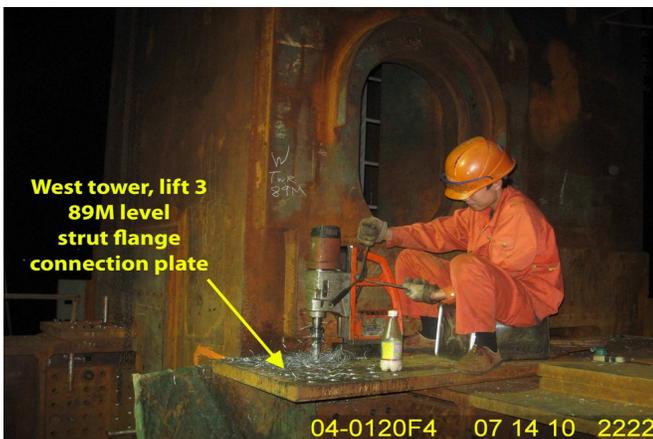
All 4 tower lifts 2 were erect with all 4 tower lifts 3 attached above, respectively. ZPMC workers were observed drilling previously scored holes in various strut flange and web connection plates at the 89M level of lifts 3. See photos below.
